FIELD ACTIVITIES

Wilmette, IL Dyed Water Flooding

**Village of Wilmette, IL
Exhibit 2
Example Setup
Legend
February 2017**

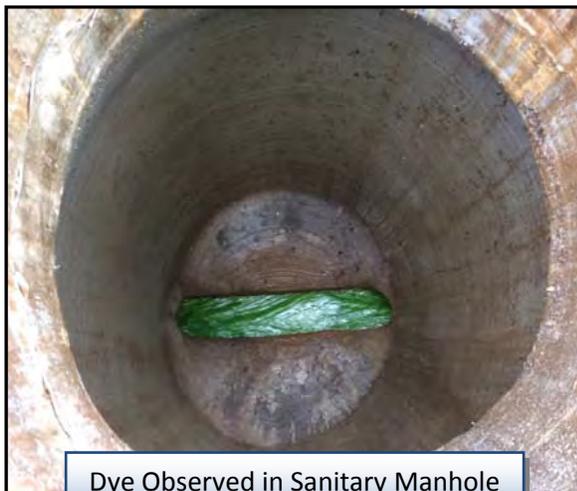
Dye Observed in Sanitary Manhole

Evidence of water leaking from the storm sewer into the sanitary sewer system was observed at thirty-four (34) of the thirty-seven (37) completed setups. The increase in flow for each setup was calculated from the pre-test and peak flow depth and velocity measurements. The locations of dyed water sources within the manholes could be seen from the surface. Defects within the sanitary sewer main are typically seen with the TV camera, where each defect was assigned an estimated gallons per minute (gpm) flow rate. However, during several dyed water flooding setups, the quantity of inflow and infiltration entering the sanitary sewer was large enough to fill the pipe

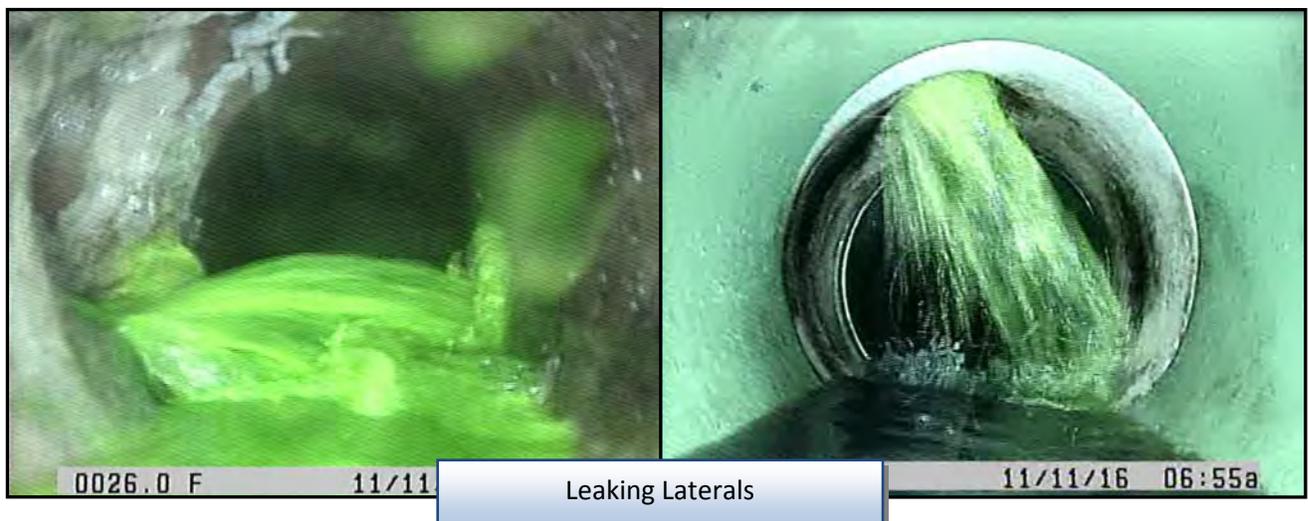
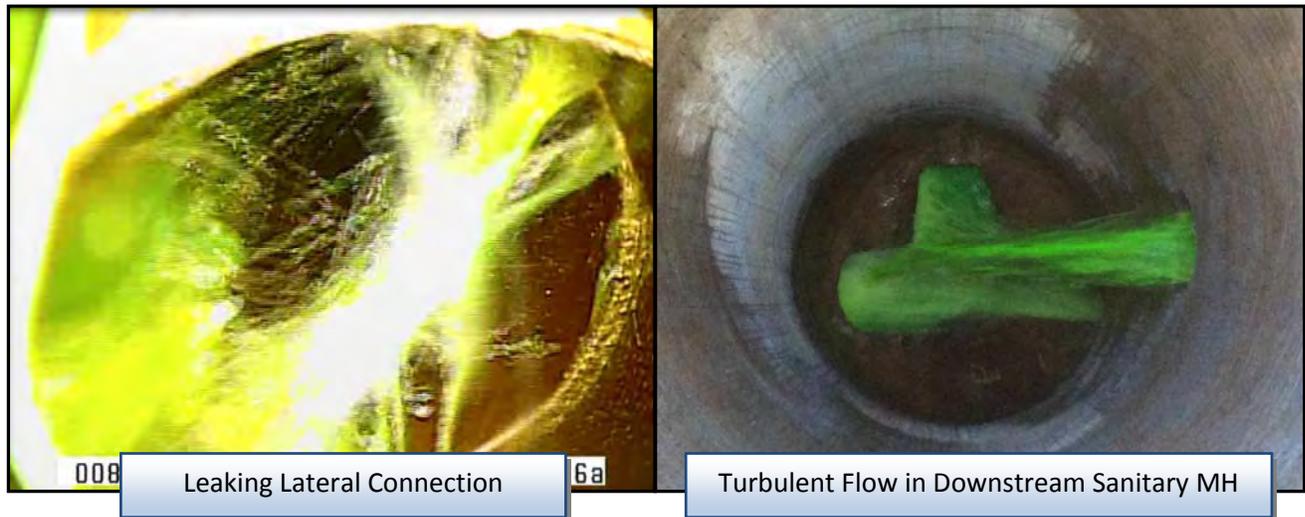
Significant sources such as leaking laterals and leaking lateral connections identified during the televising are shown in the pictures below.

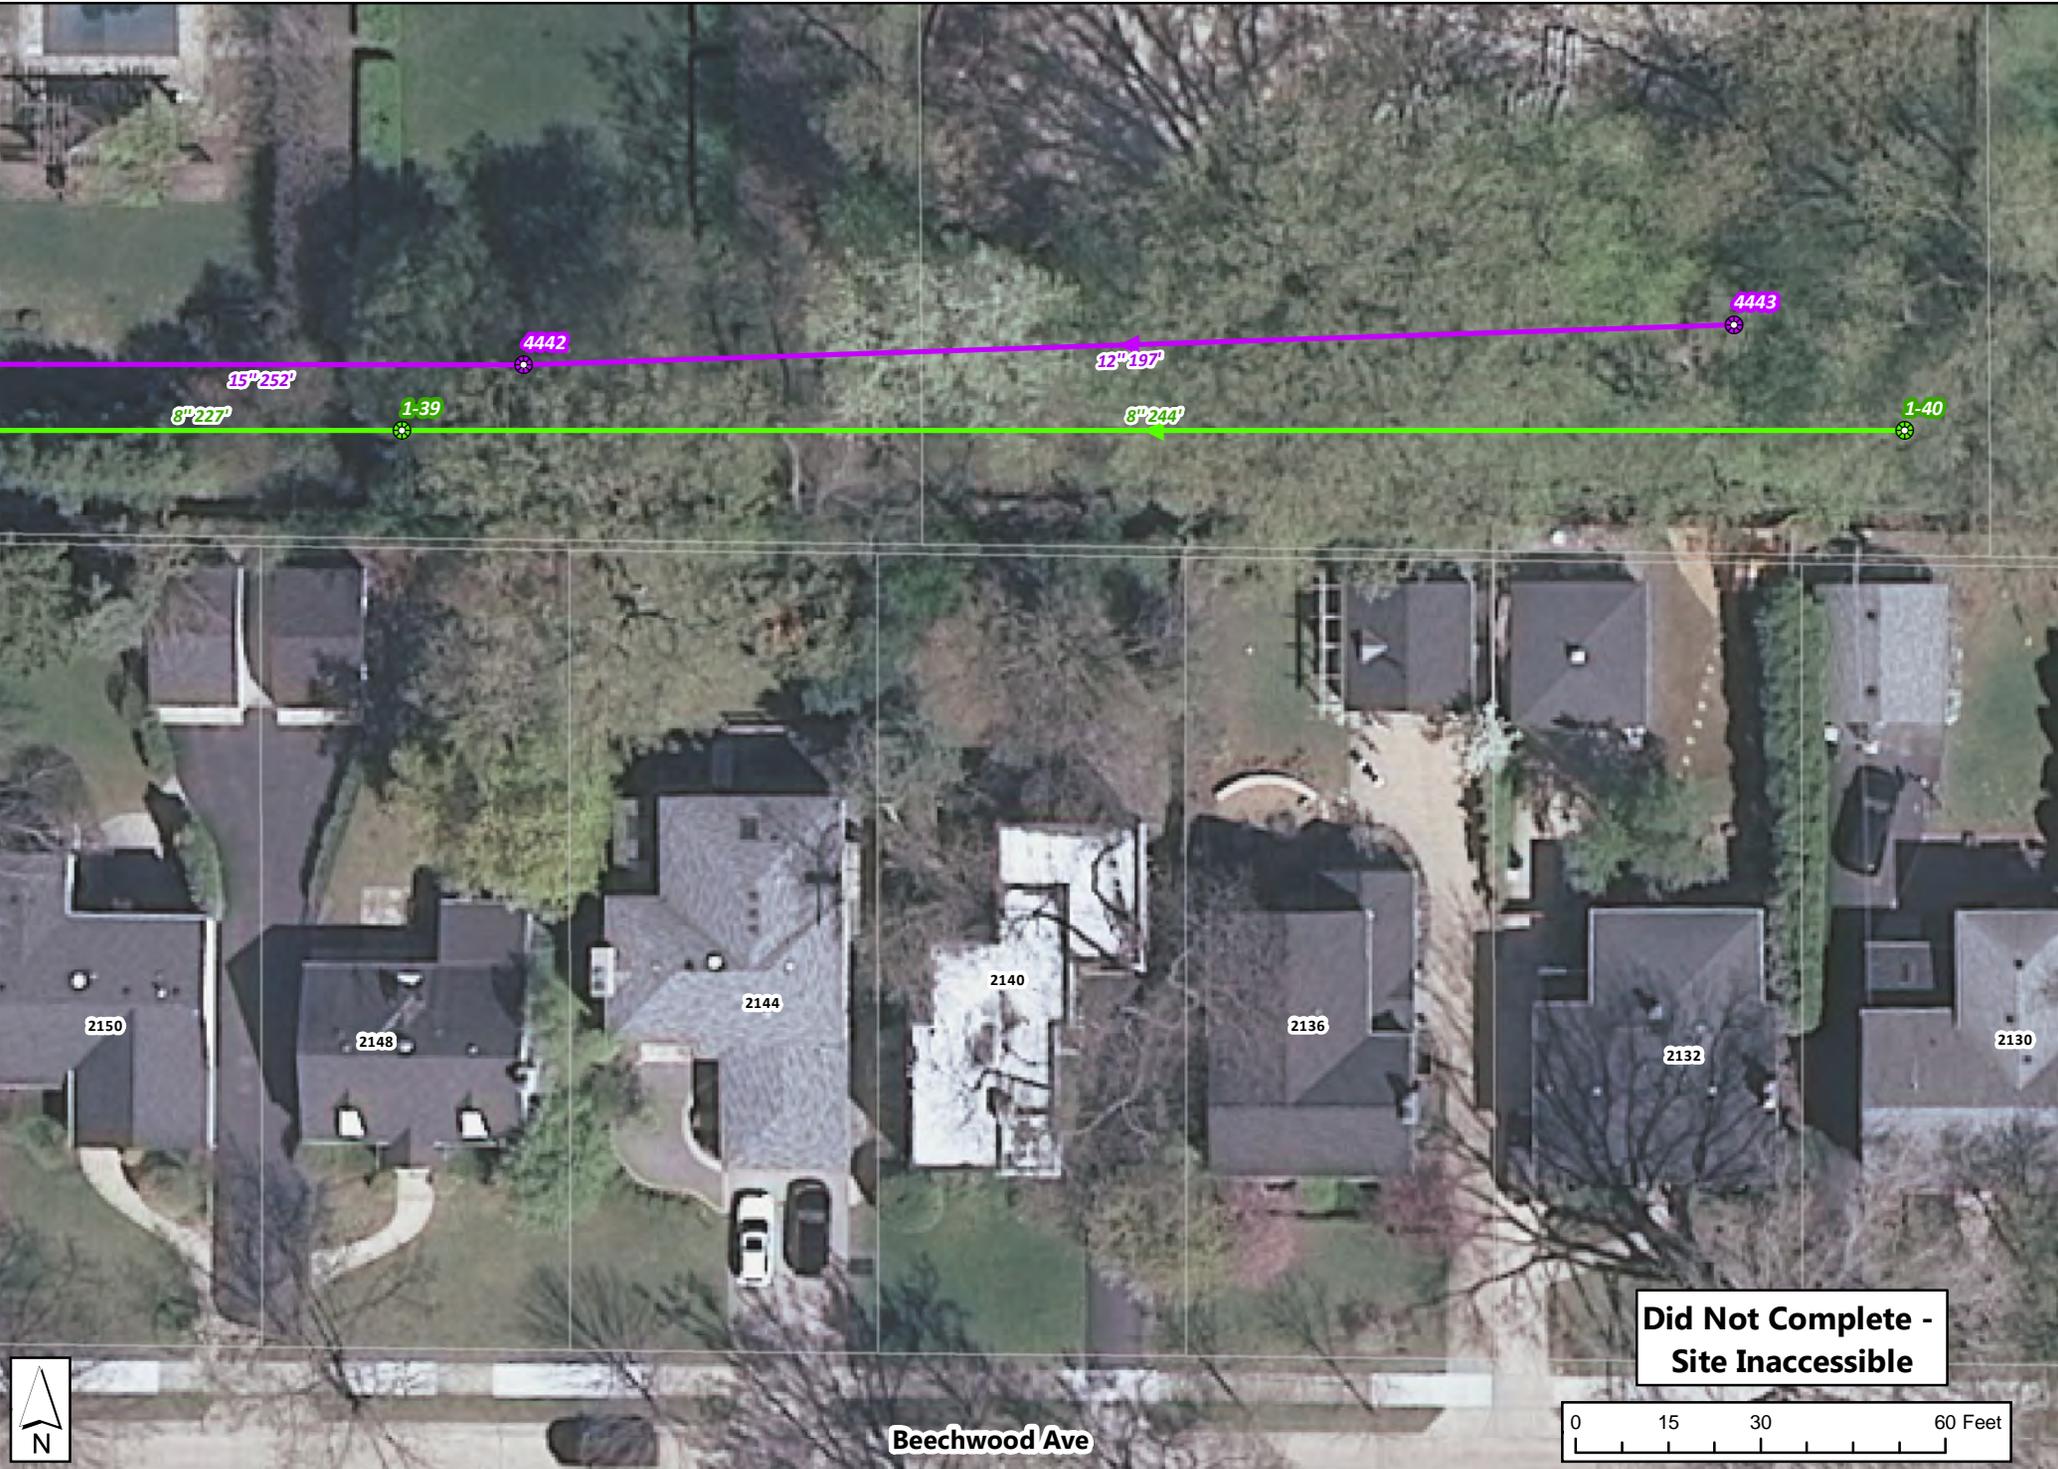
**Did Not Complete -
Site Inaccessible**

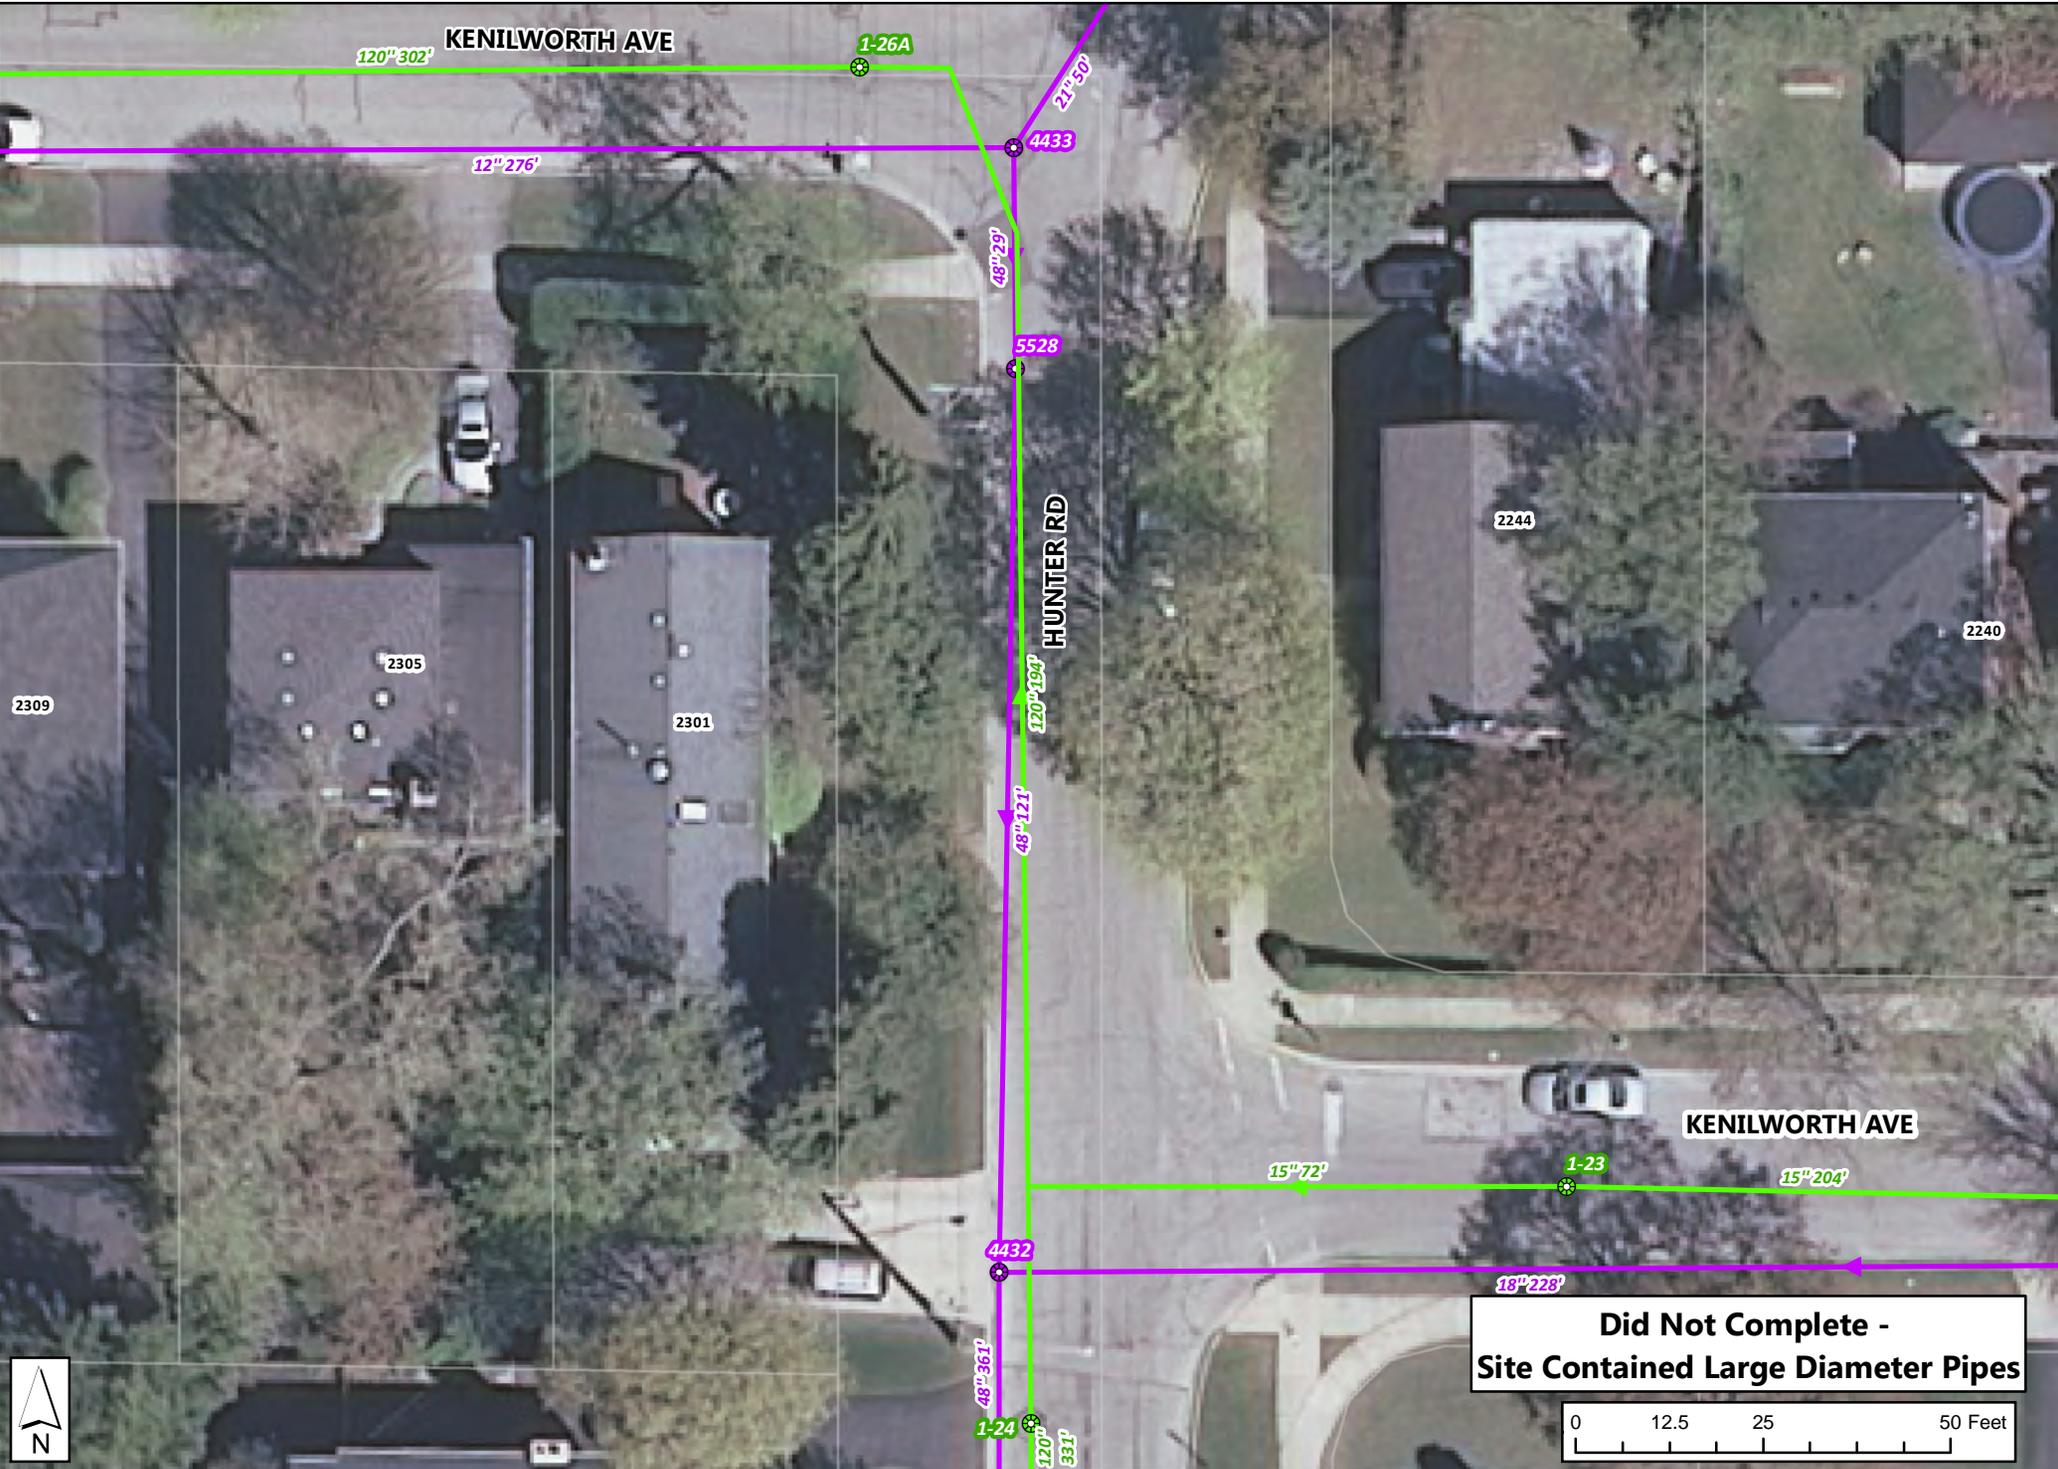
**Did Not Complete -
Site Contained Large Diameter Pipes**

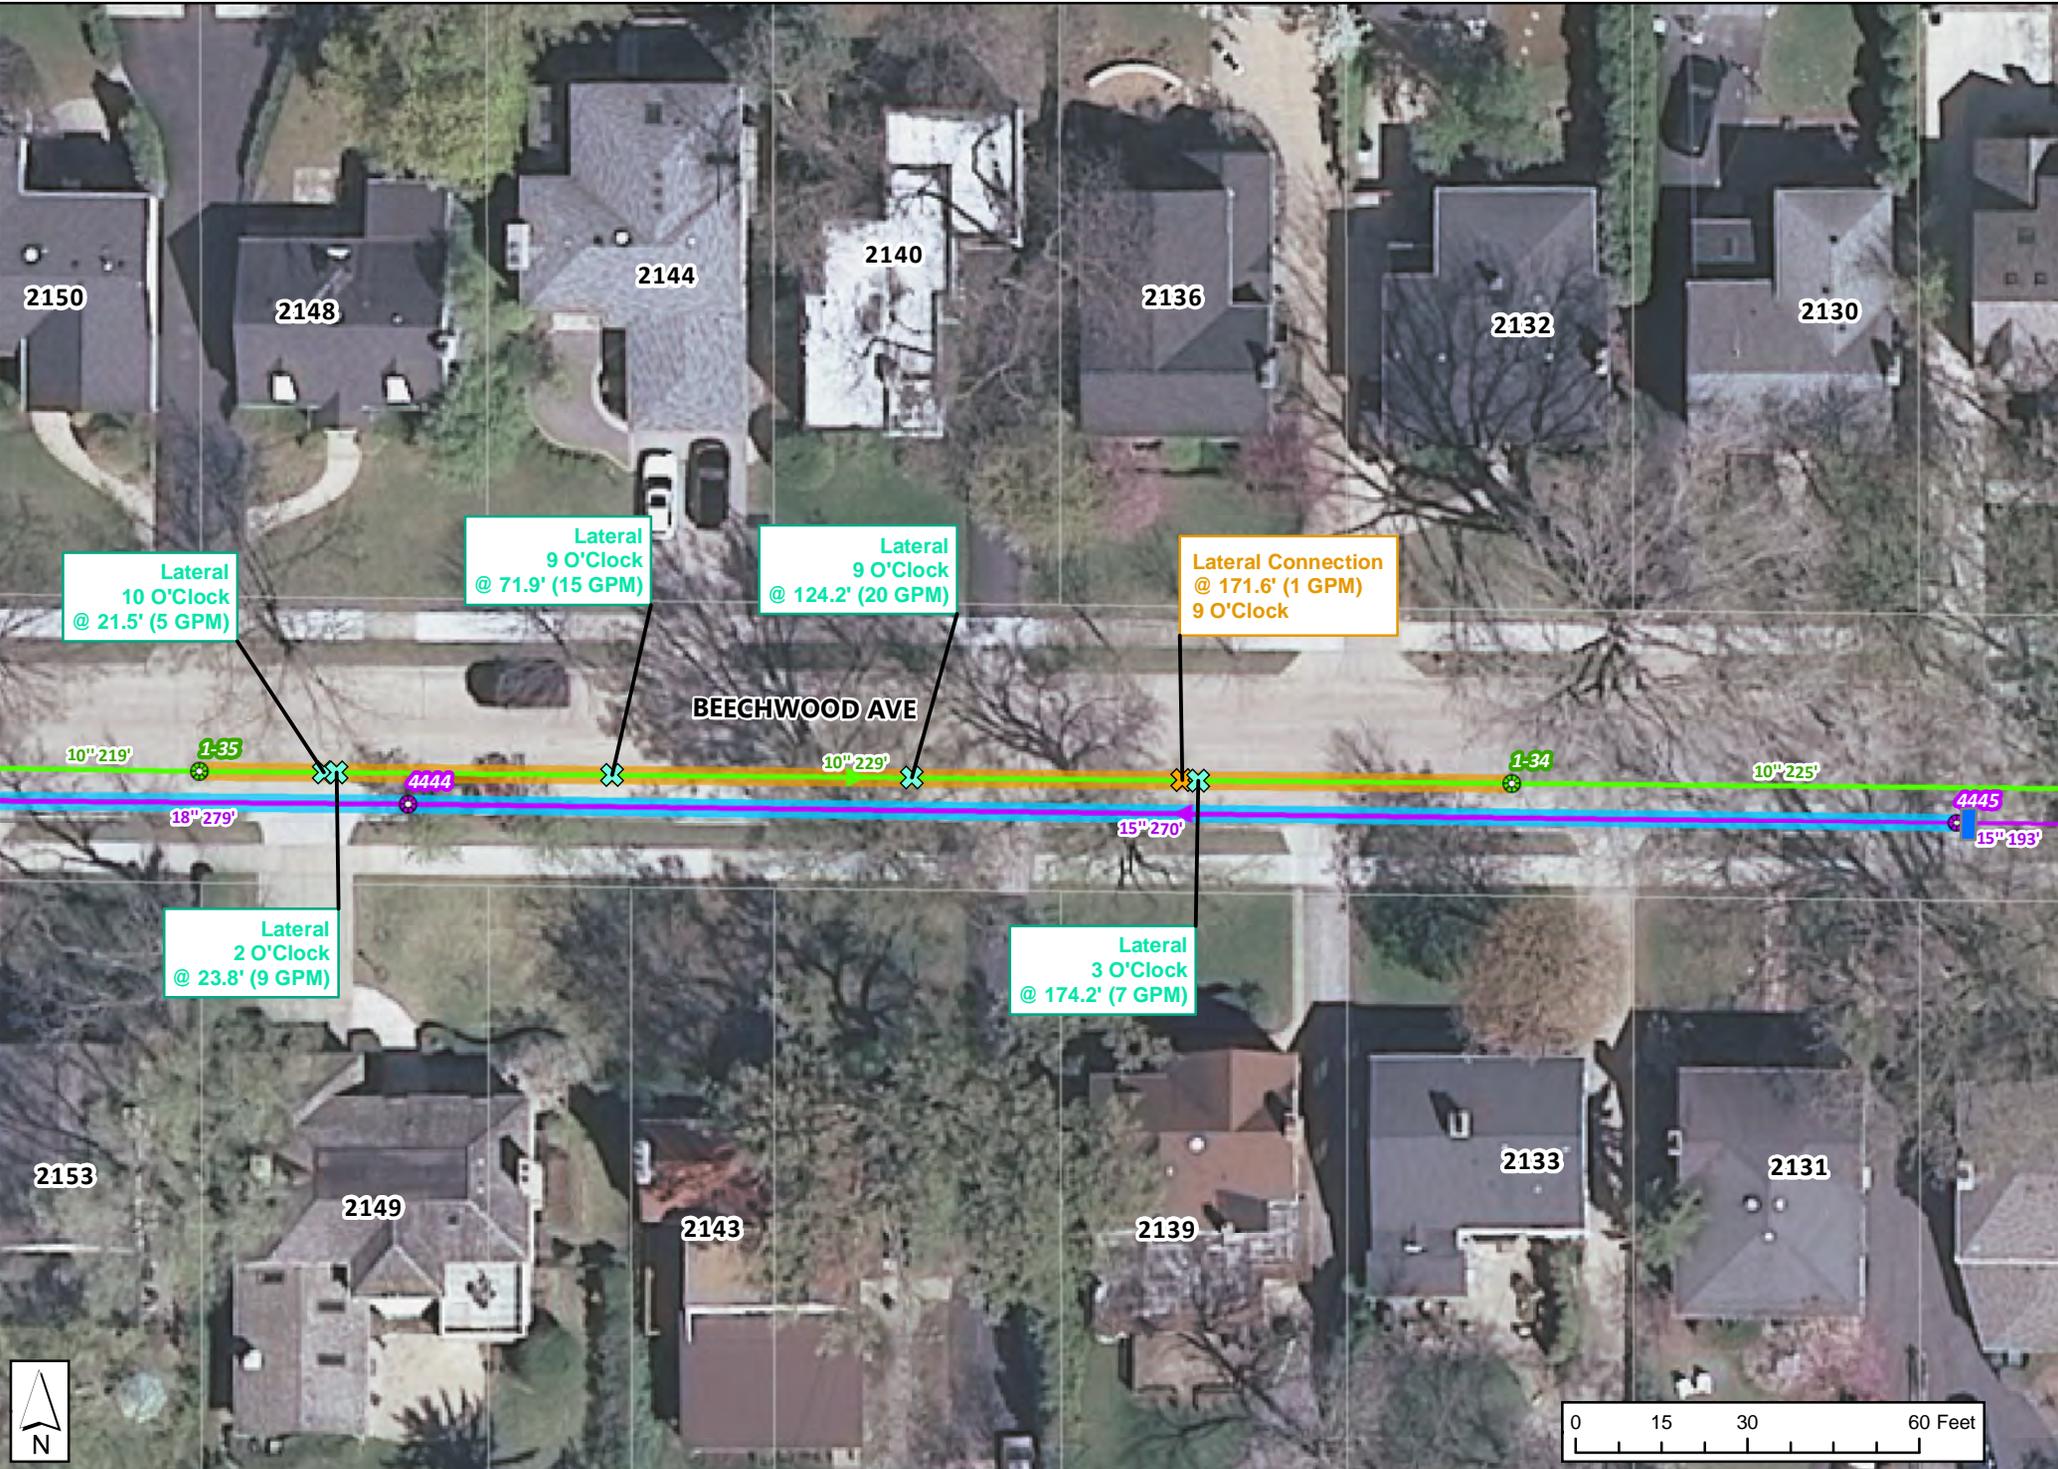
Village of Wilmette, IL
Exhibit 8
Dyed Water Flooding:
Setup 6: 1-35 to 1-34
February 2017

**2016 Wilmette Dyed Water Flooding
Setup 6 (57 GPM)**

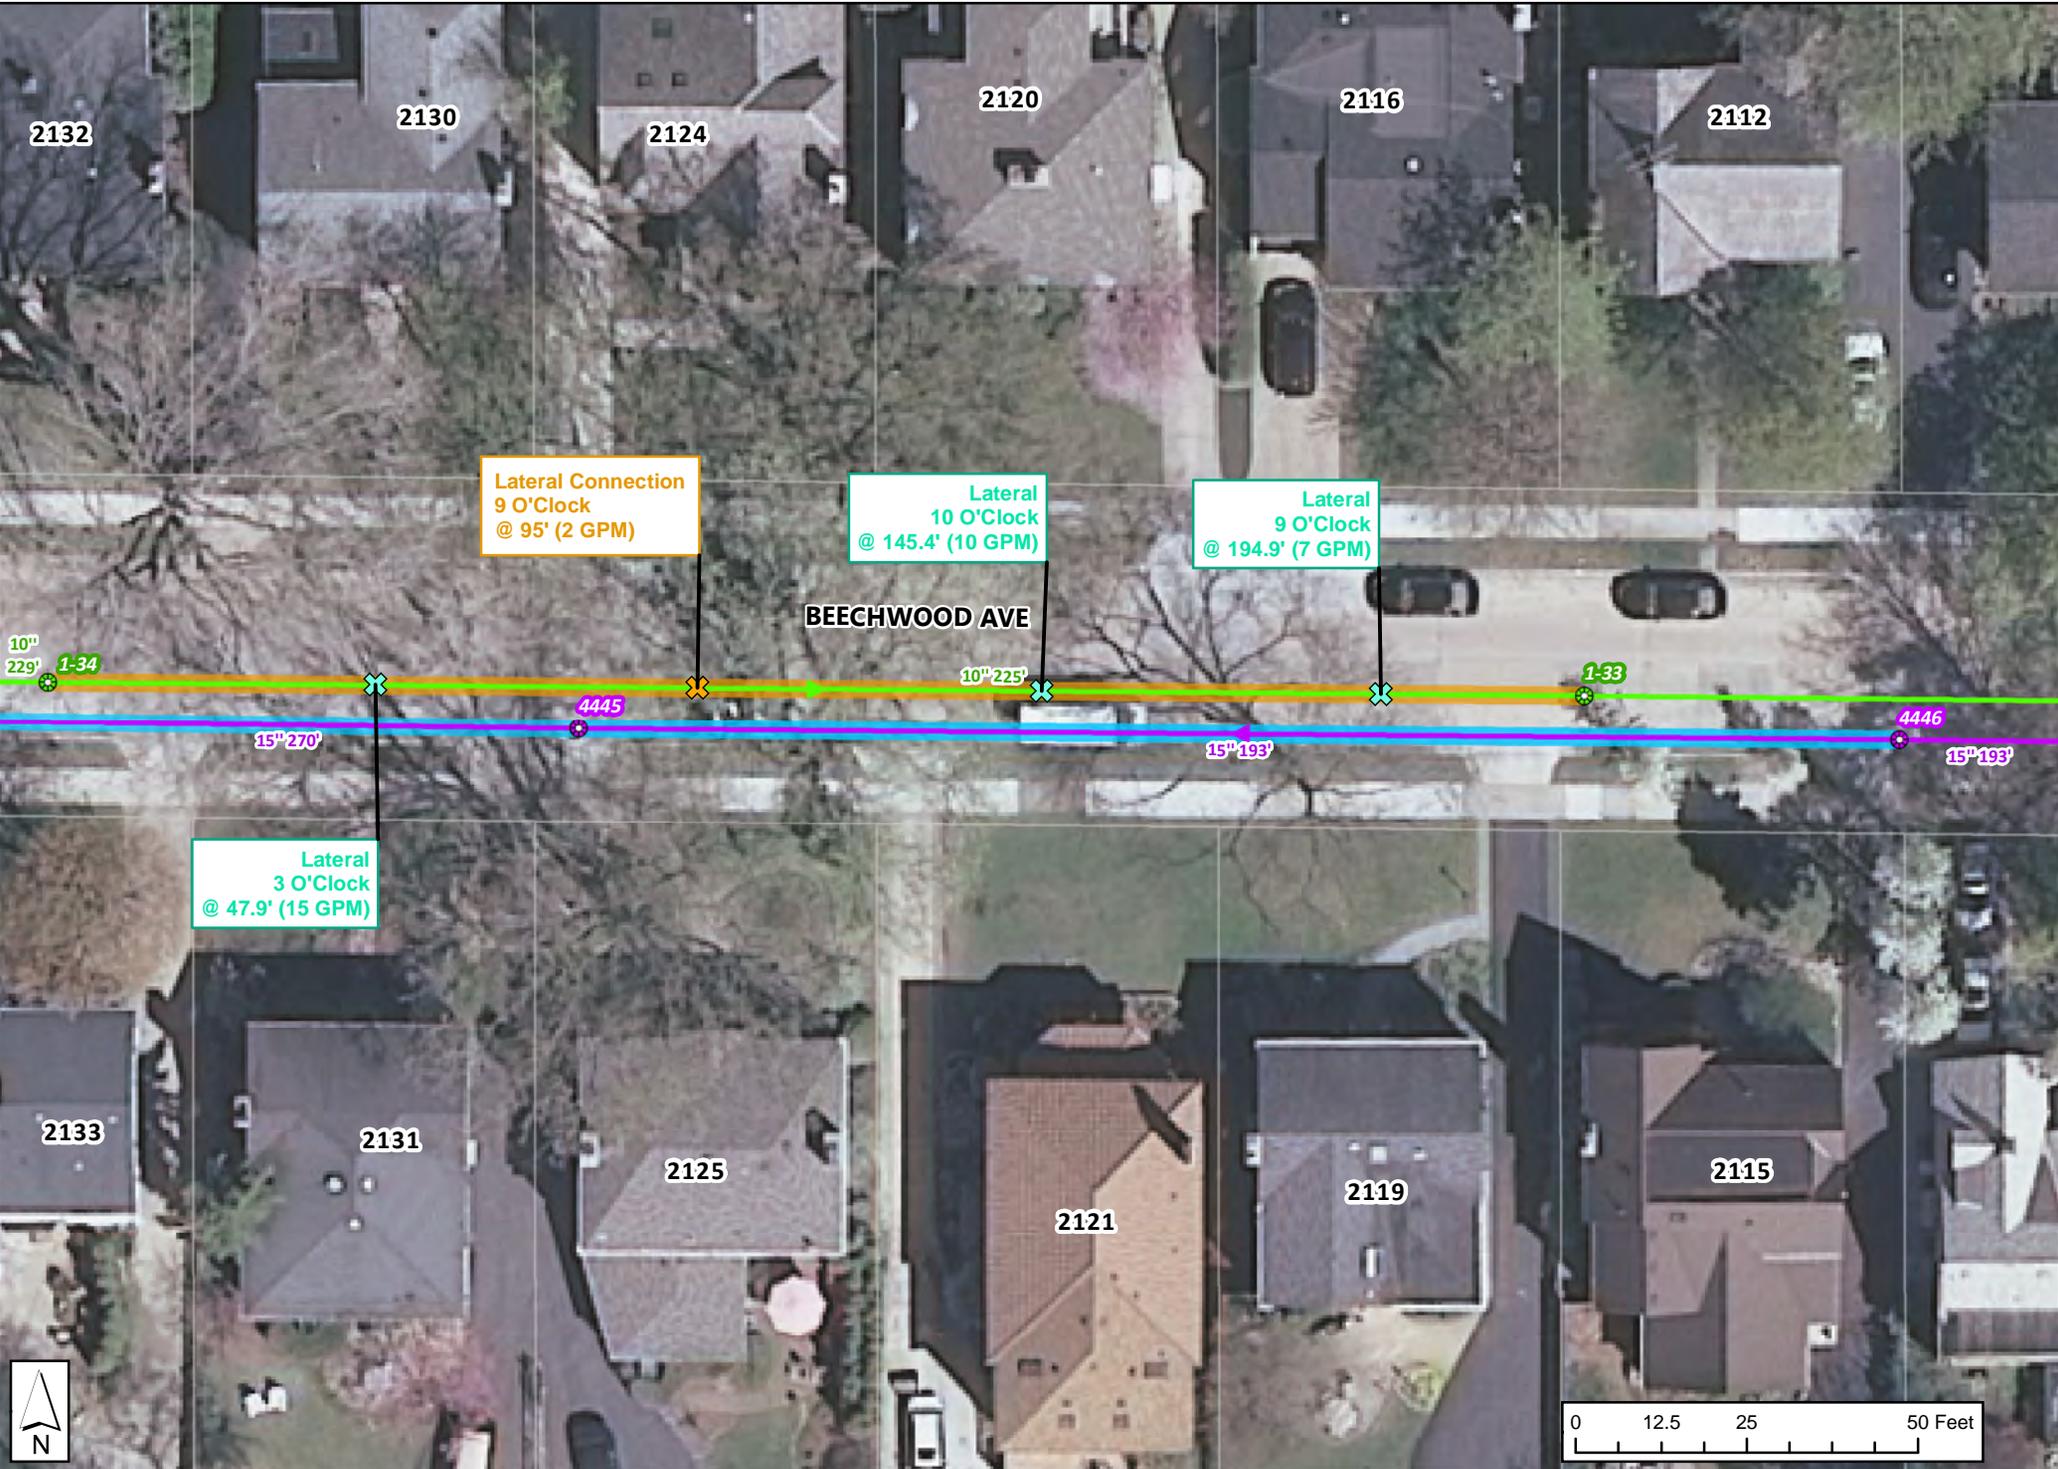
Lateral Connection
9 O'Clock
@ 95' (2 GPM)

Lateral
10 O'Clock
@ 145.4' (10 GPM)

Lateral
9 O'Clock
@ 194.9' (7 GPM)

Lateral
3 O'Clock
@ 47.9' (15 GPM)

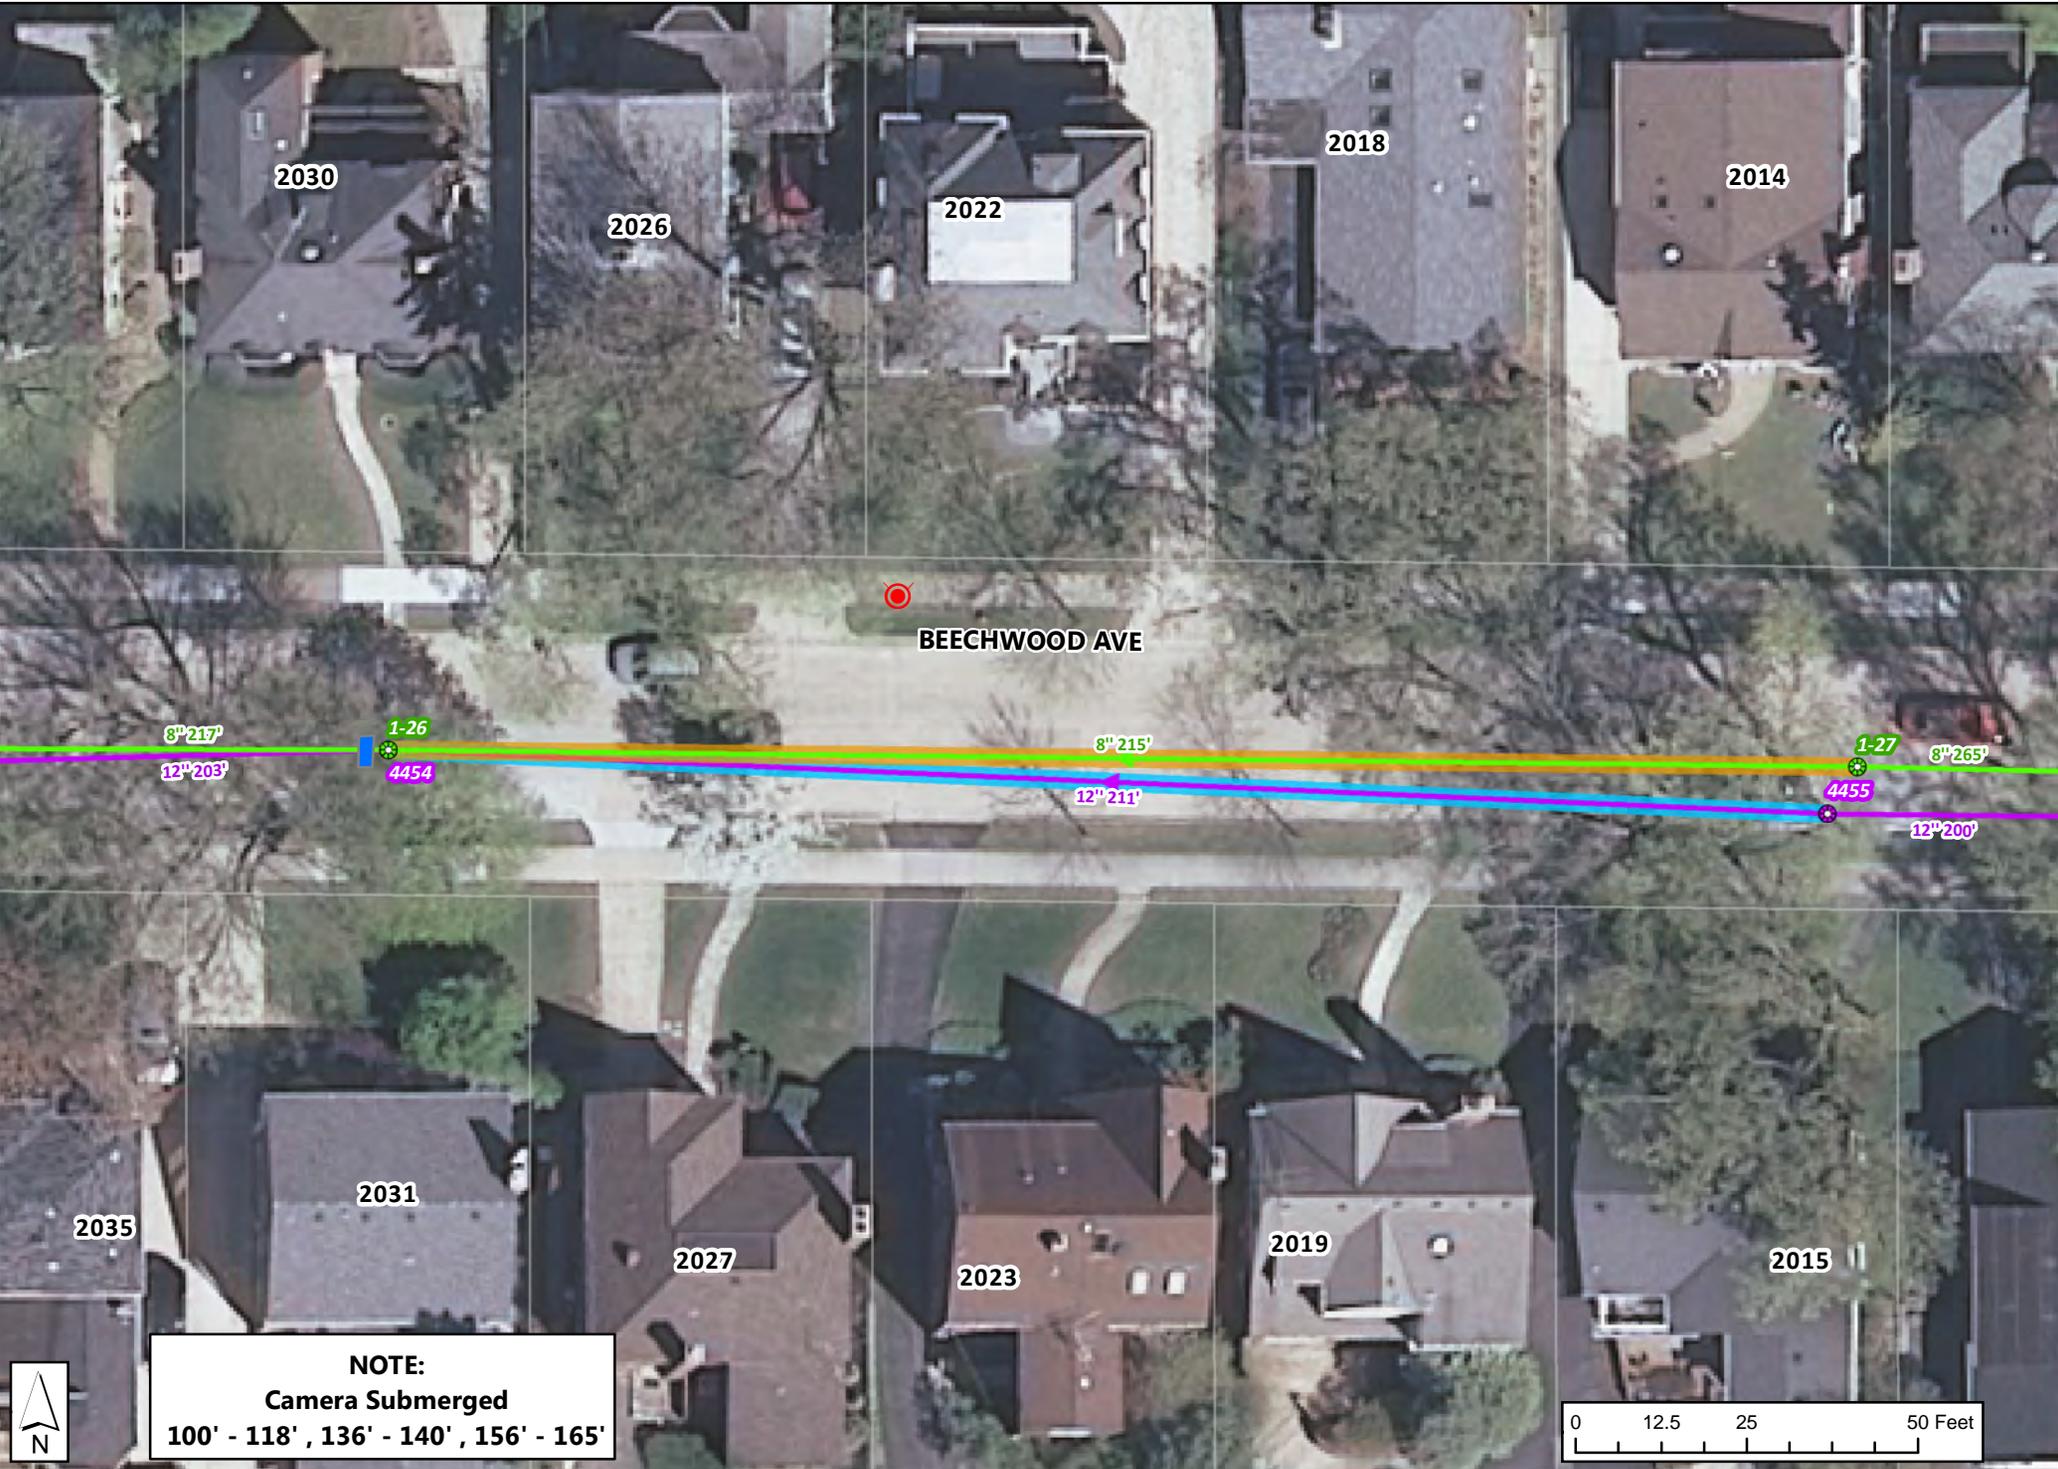
Village of Wilmette, IL
 Exhibit 12
 Dyed Water Flooding:
 Setup 9: 1-27 to 1-26
 February 2017

NOTE:
Camera Submerged
 100' - 118' , 136' - 140' , 156' - 165'

**2016 Wilmette Dyed Water Flooding
 Setup 9 (0 GPM)**

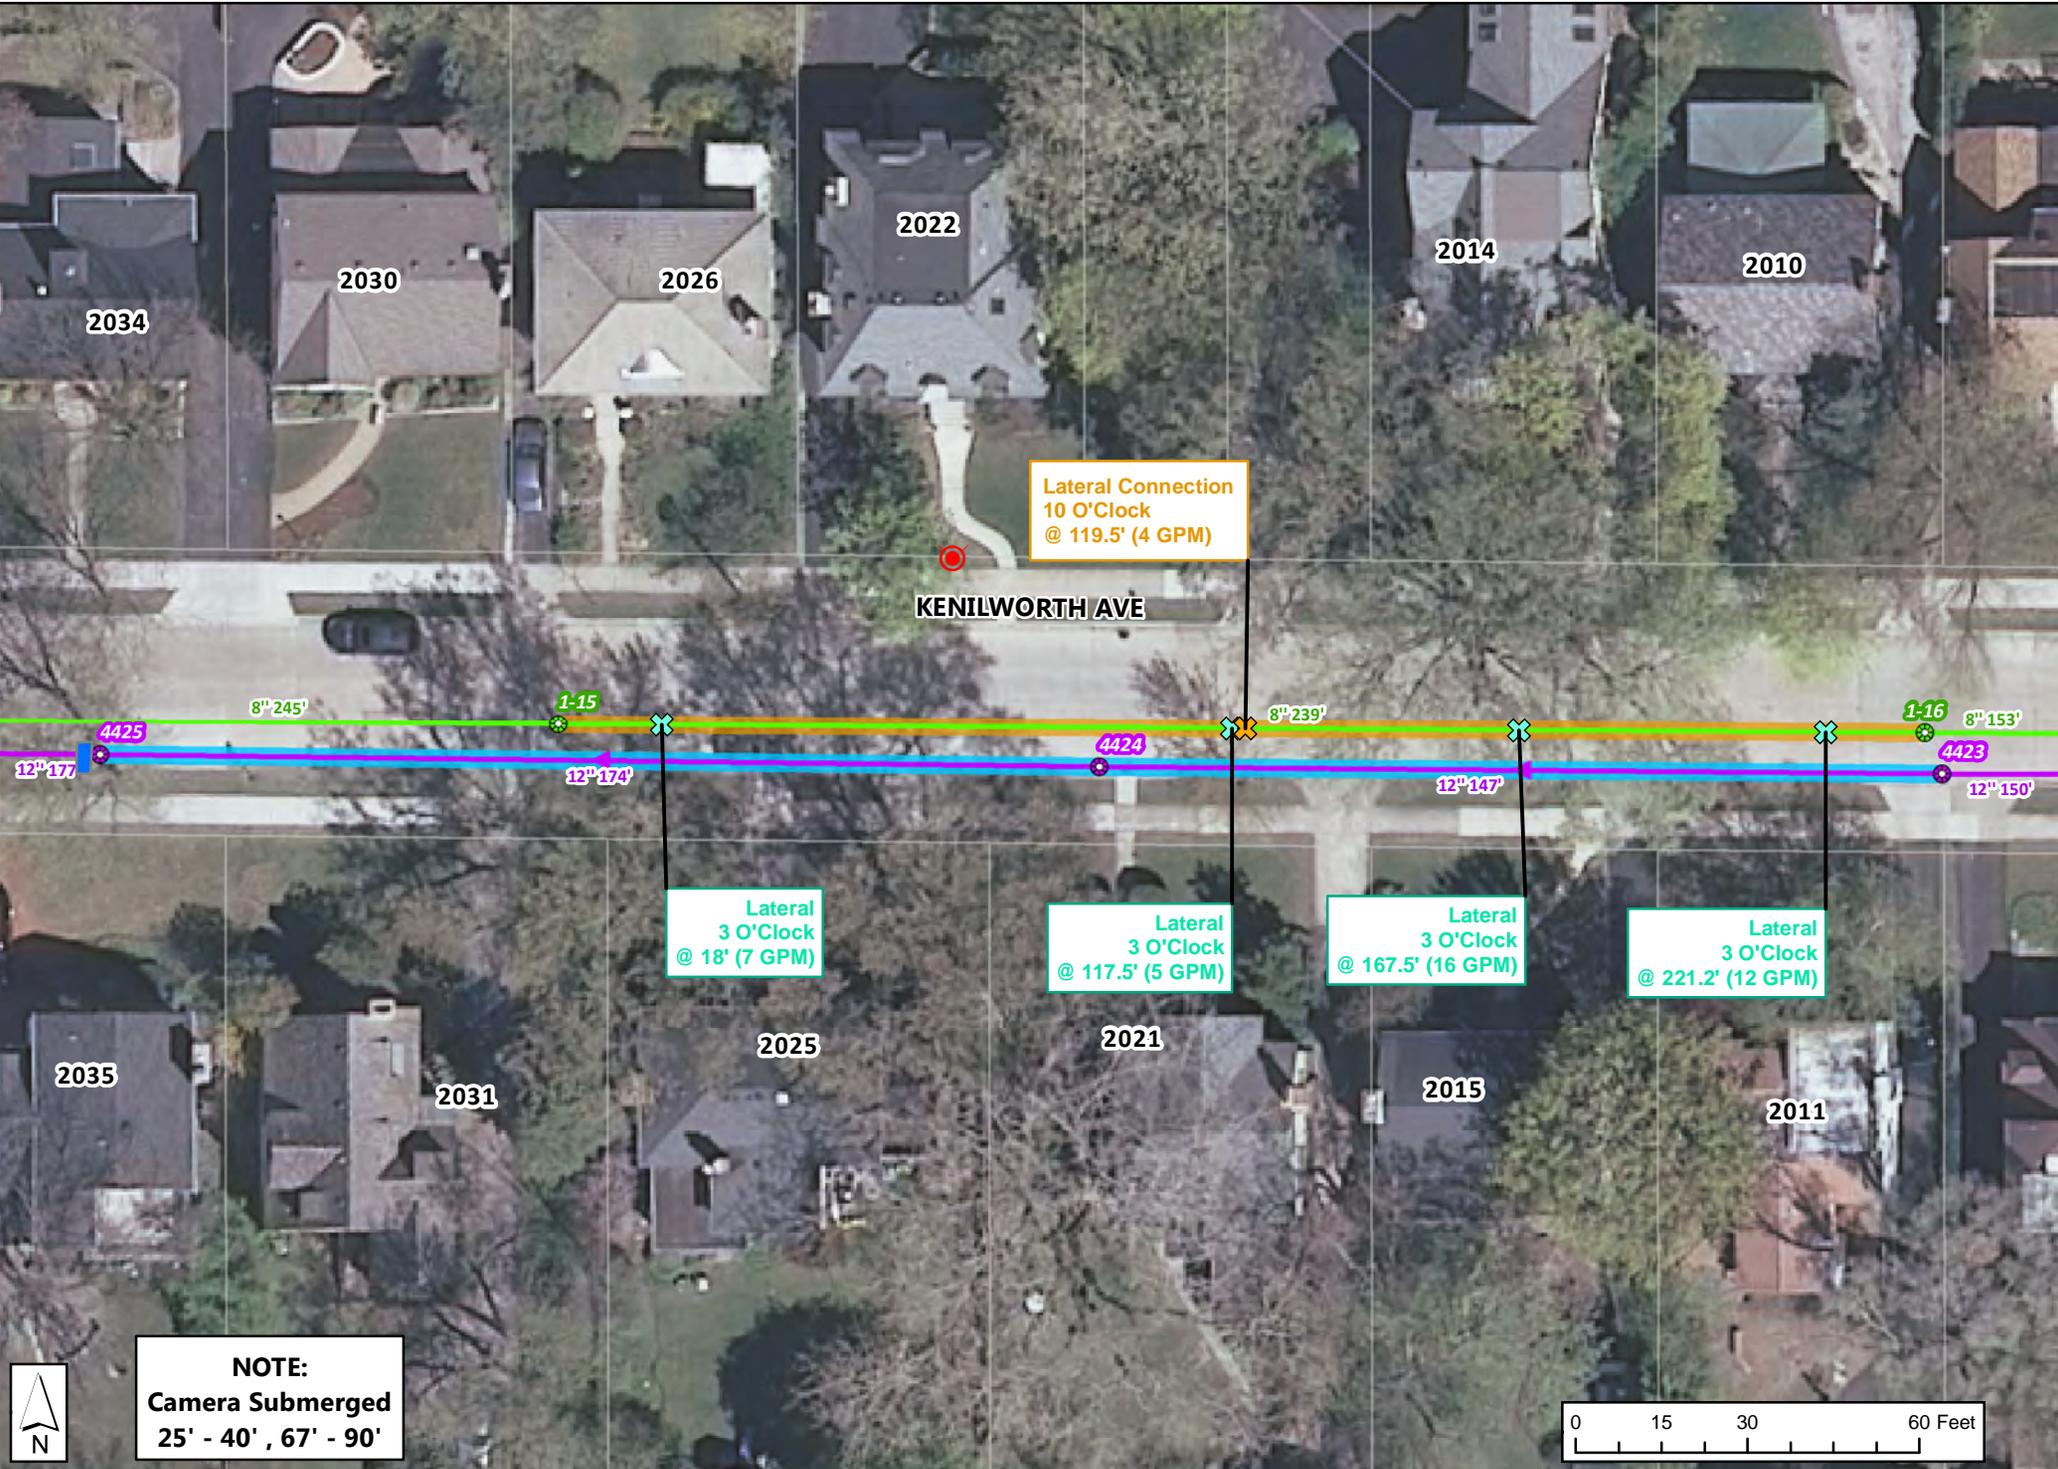
Lateral Connection
10 O'Clock
@ 119.5' (4 GPM)

Lateral
3 O'Clock
@ 18' (7 GPM)

Lateral
3 O'Clock
@ 117.5' (5 GPM)

Lateral
3 O'Clock
@ 167.5' (16 GPM)

Lateral
3 O'Clock
@ 221.2' (12 GPM)

NOTE:
Camera Submerged
25' - 40' , 67' - 90'

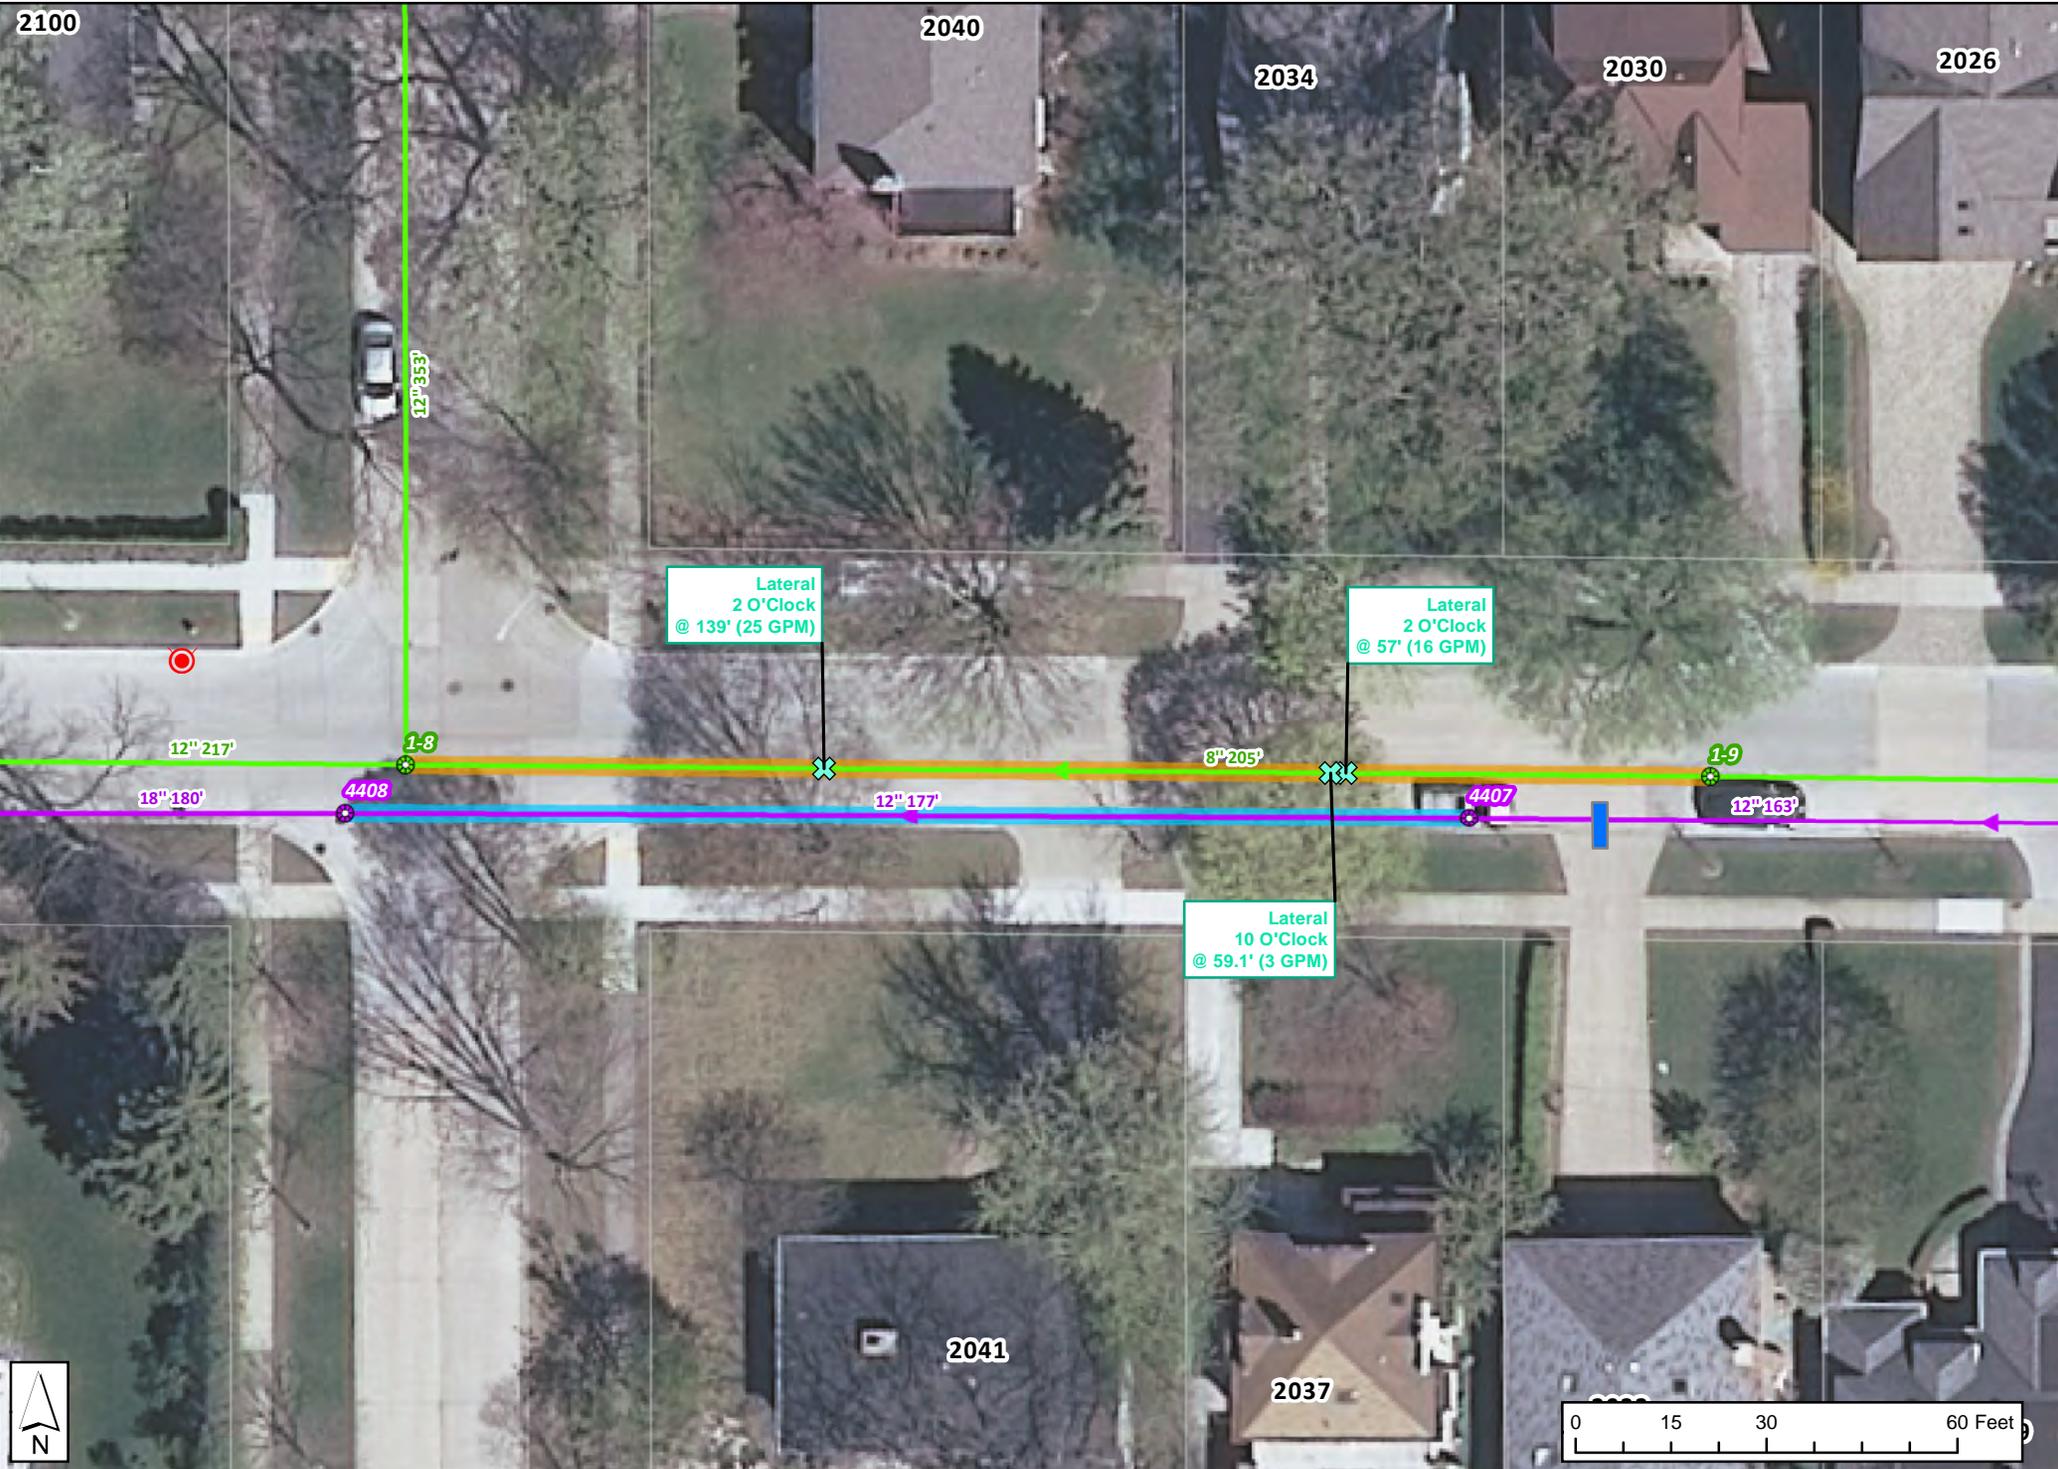
City of Wilmette, IL
Exhibit 24
Dyed Water Flooding:
Setup 21: 1-9 to 1-8
February 2017

**2016 Wilmette Dyed Water Flooding
Setup 21 (44 GPM)**
