FIELD ACTIVITIES

Wilmette, IL Dyed Water Flooding

**Village of Wilmette, IL
Exhibit 2
Example Setup
Legend
February 2017**

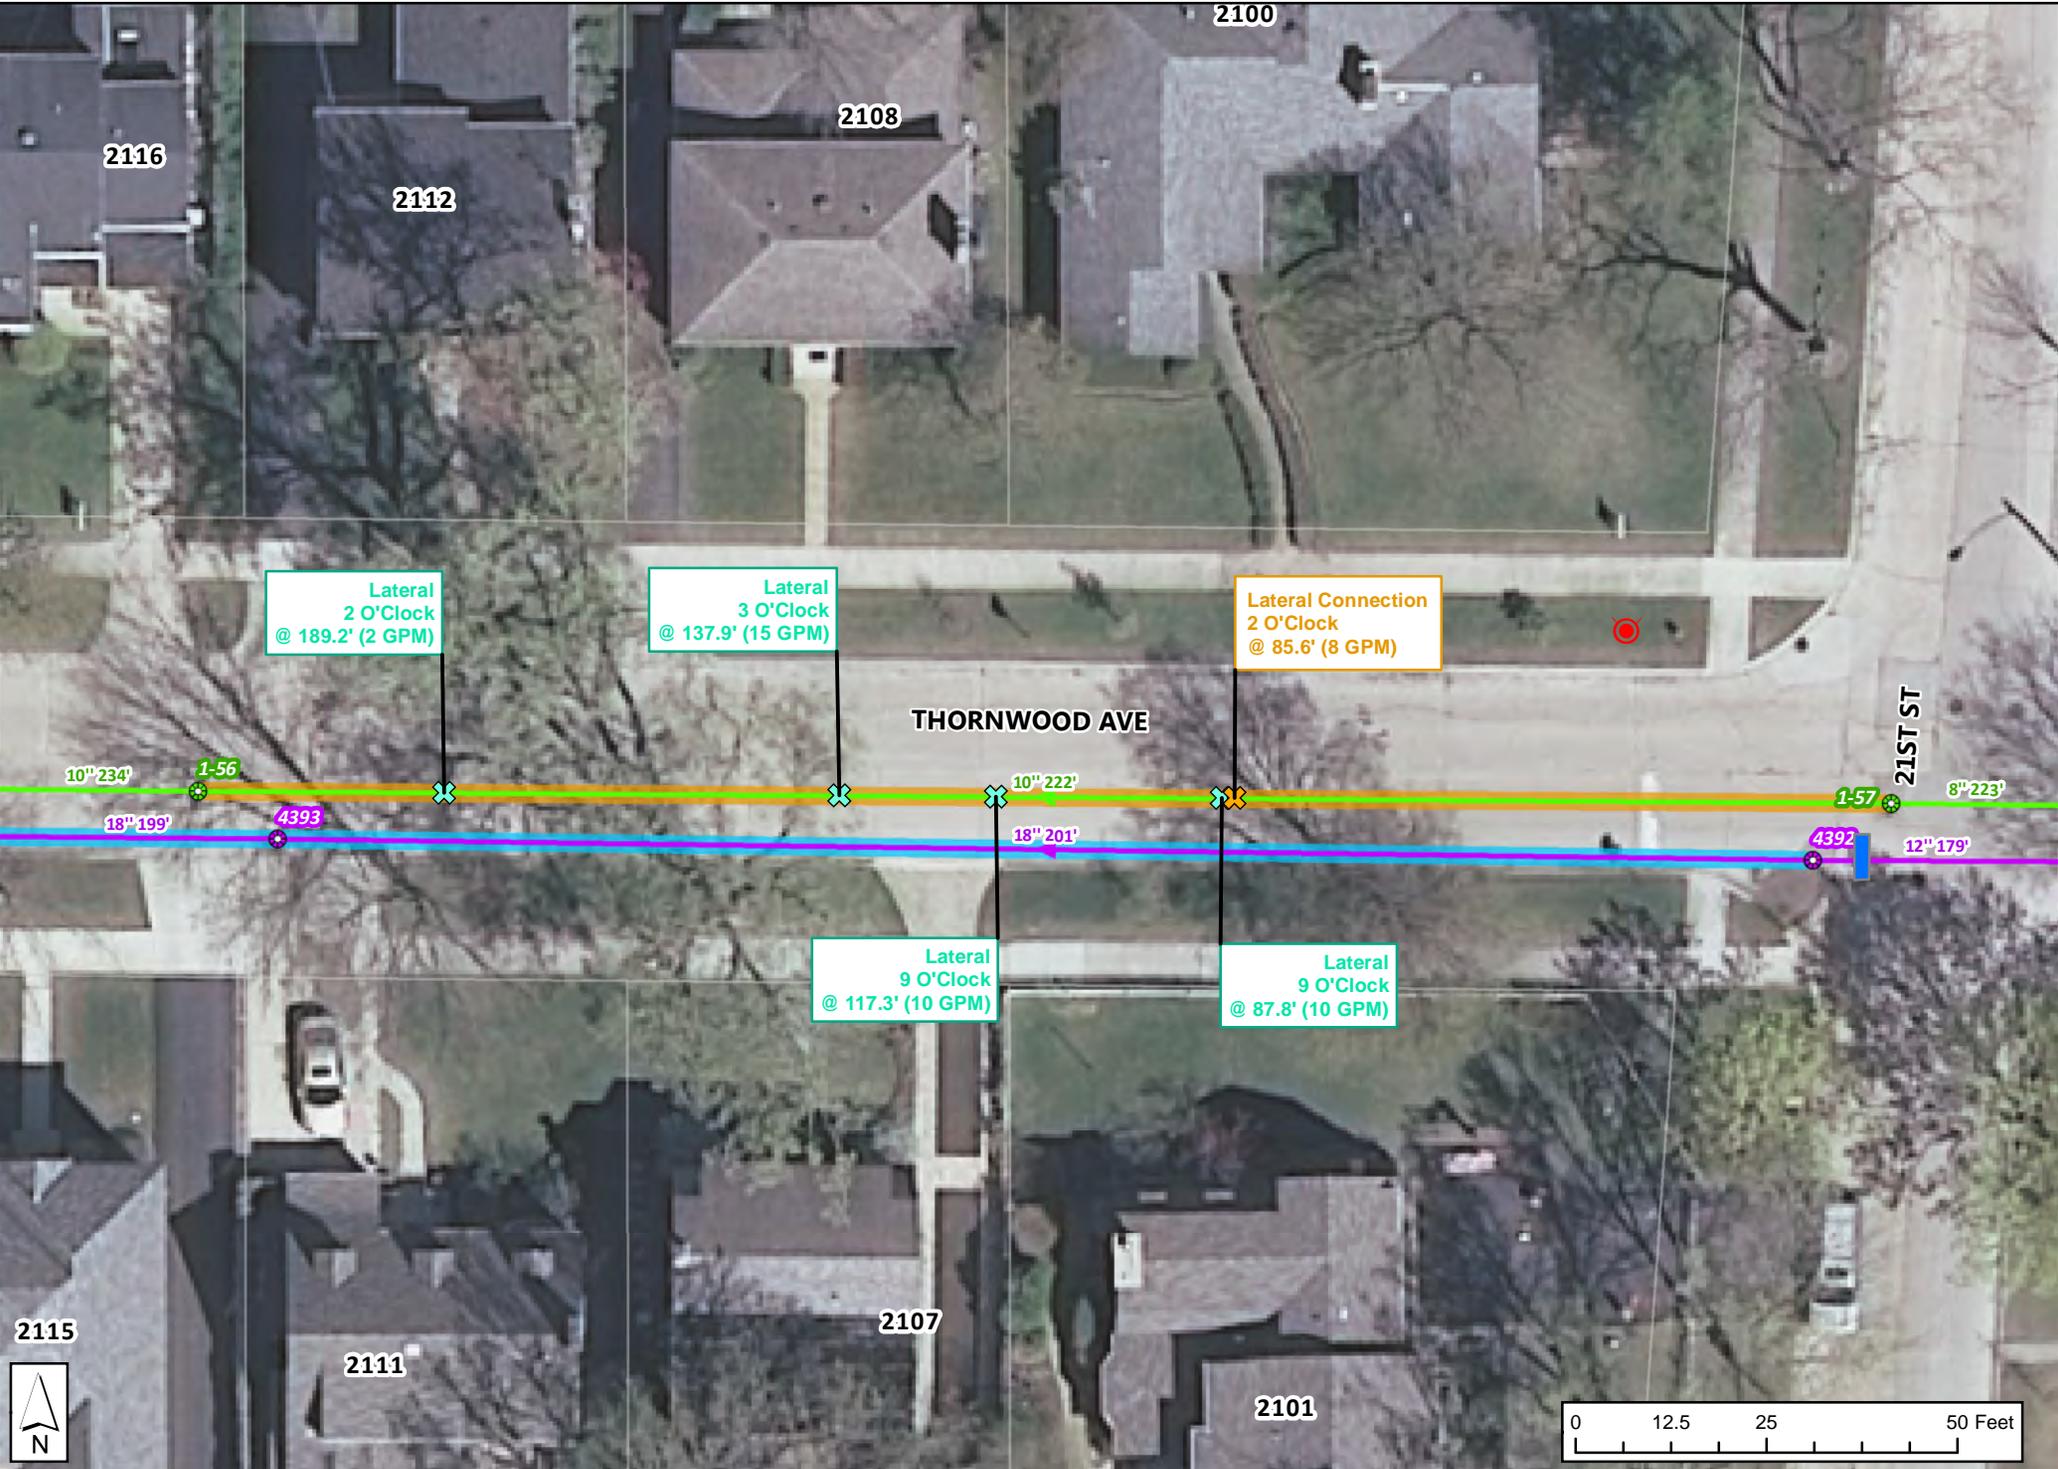
Lateral
2 O'Clock
@ 189.2' (2 GPM)

Lateral
3 O'Clock
@ 137.9' (15 GPM)

Lateral Connection
2 O'Clock
@ 85.6' (8 GPM)

Lateral
9 O'Clock
@ 117.3' (10 GPM)

Lateral
9 O'Clock
@ 87.8' (10 GPM)

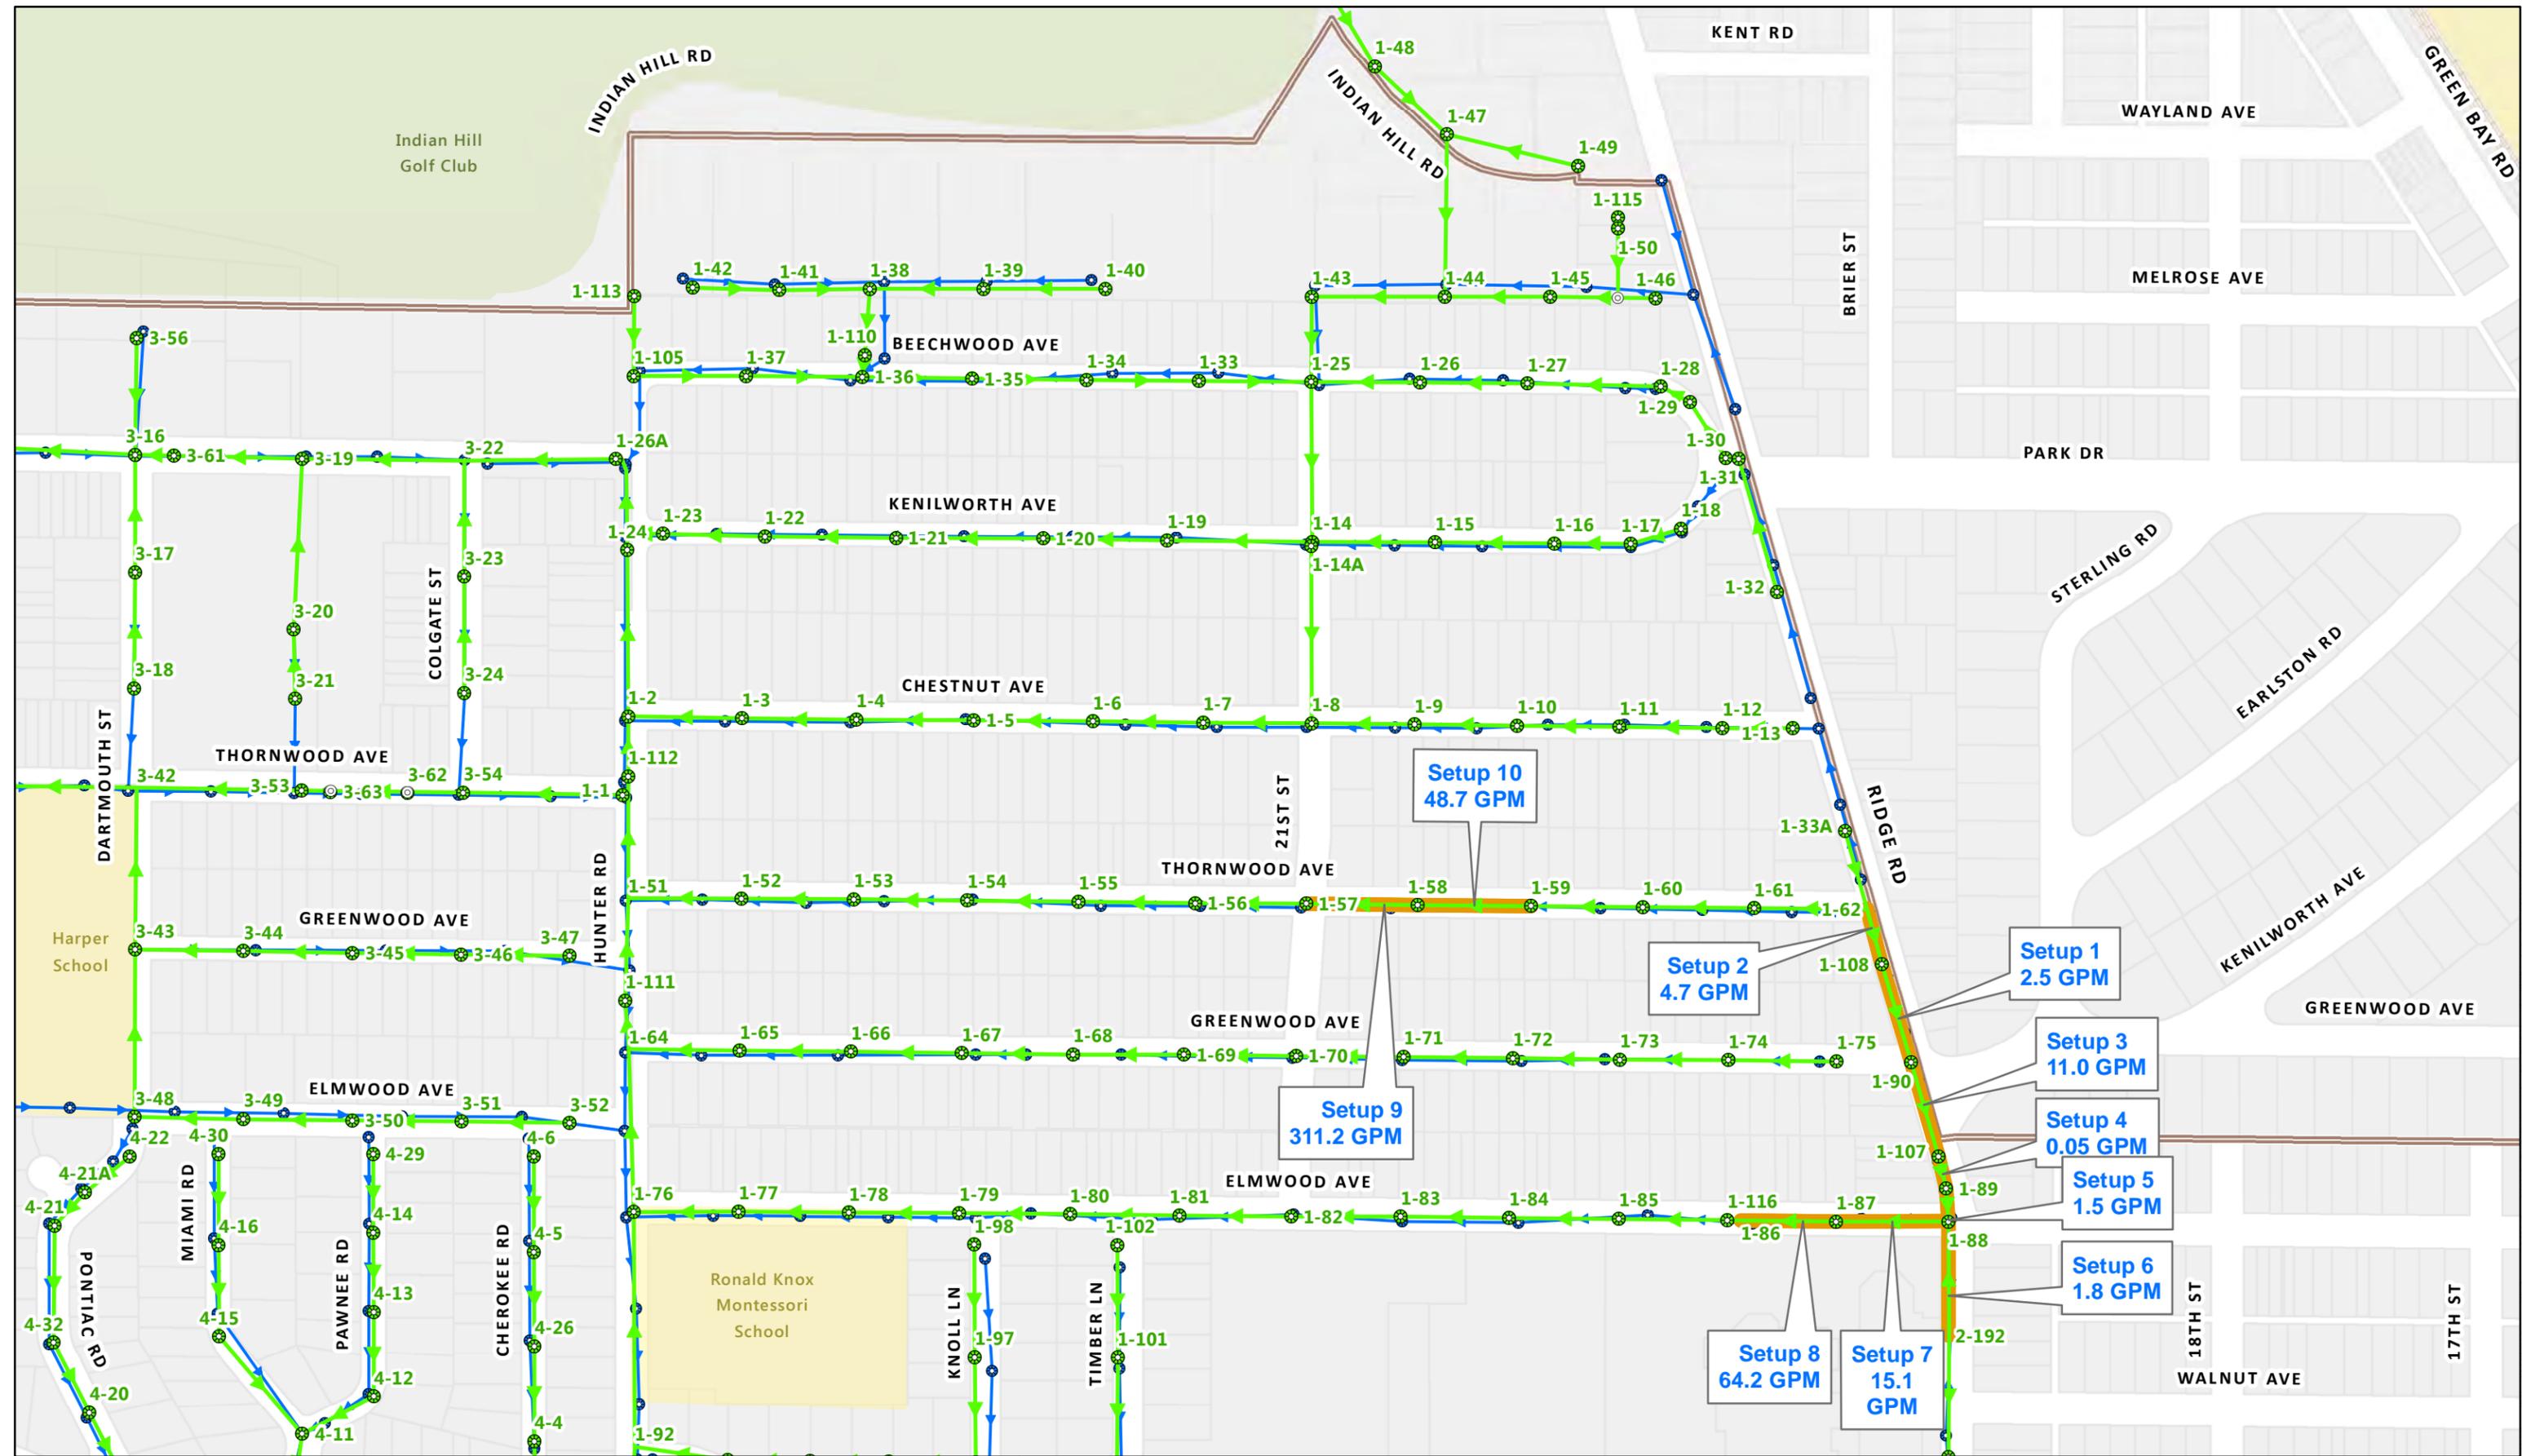
Village of Wilmette, IL
Exhibit 44
Kenilworth Gardens Dye Water Flooding:
Setup 2 Segments 1-108 to 1-62
June 2014

SETUP 2, 1-62 to 1-108 (4.4 GPM)
