NOTICE OF MEETING

The **Municipal Services Committee** of the Board of Trustees of the Village of Wilmette will hold a meeting on **Tuesday, July 9, 2013 at 5:00 p.m.**, in the Council Chambers at Wilmette Village Hall, 1200 Wilmette Avenue, Wilmette, Illinois.

To: Ms. Brigitte Mayerhofer, P.E.
From: Vincent Bergl, P.E.
Date: July 3, 2013
Re: Harms Region Storage Summary – Cost-Benefit Analysis of Storage Volume

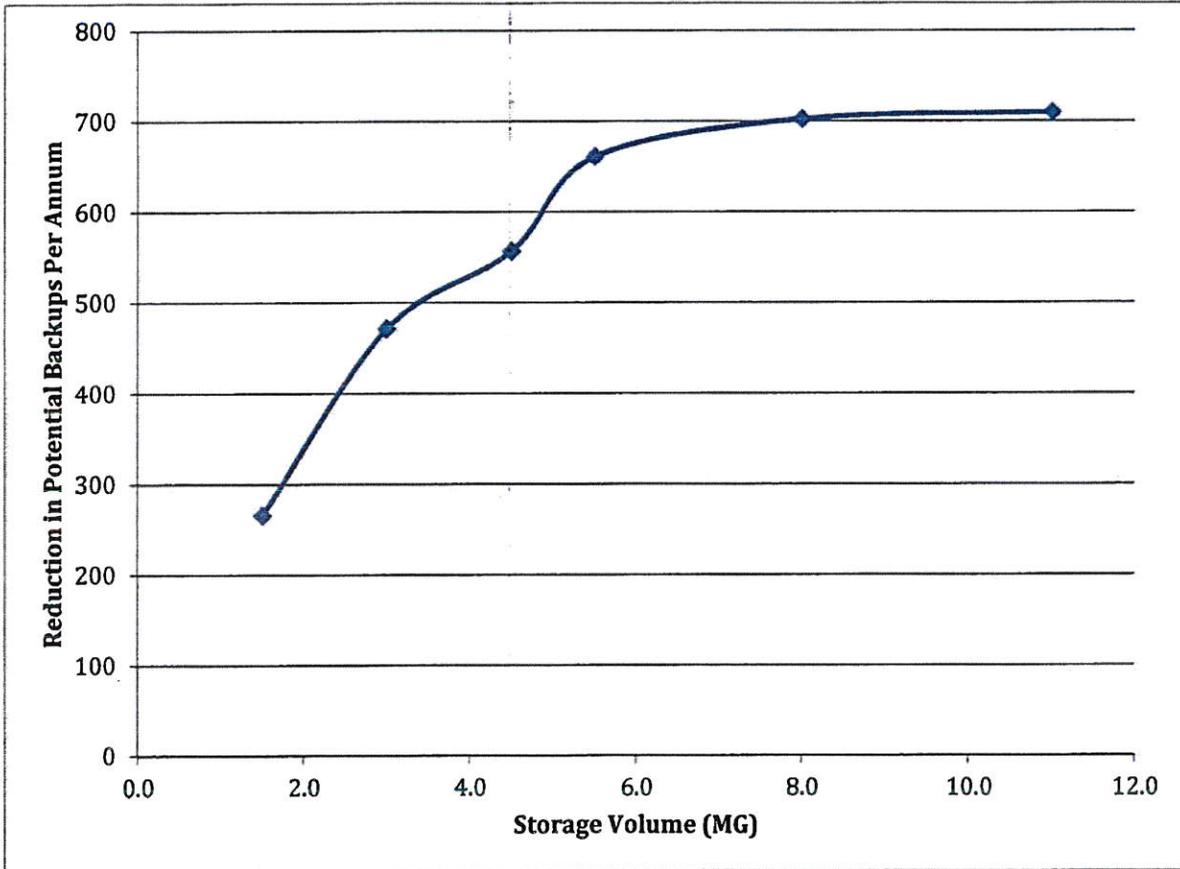
Figure 1
Reduction in Backups by Volume of Gravity-Drained Storage

The relationship between volume of gravity-drained storage and the reduction in potential sewer backups is illustrated by Figure 1. As the figure illustrates, the benefit of additional storage volume is steepest up to 3.0 MG, and the added benefit beyond 5.5 MG tapers off as the capacity of tributary sewers to convey additional flow to the detention basin becomes a limiting factor in the effectiveness of larger storage volumes. Given the minimal benefits of volumes in excess of 5.5 M G and the added difficulty of providing storage at multiple sites, these alternatives were excluded from further analysis.

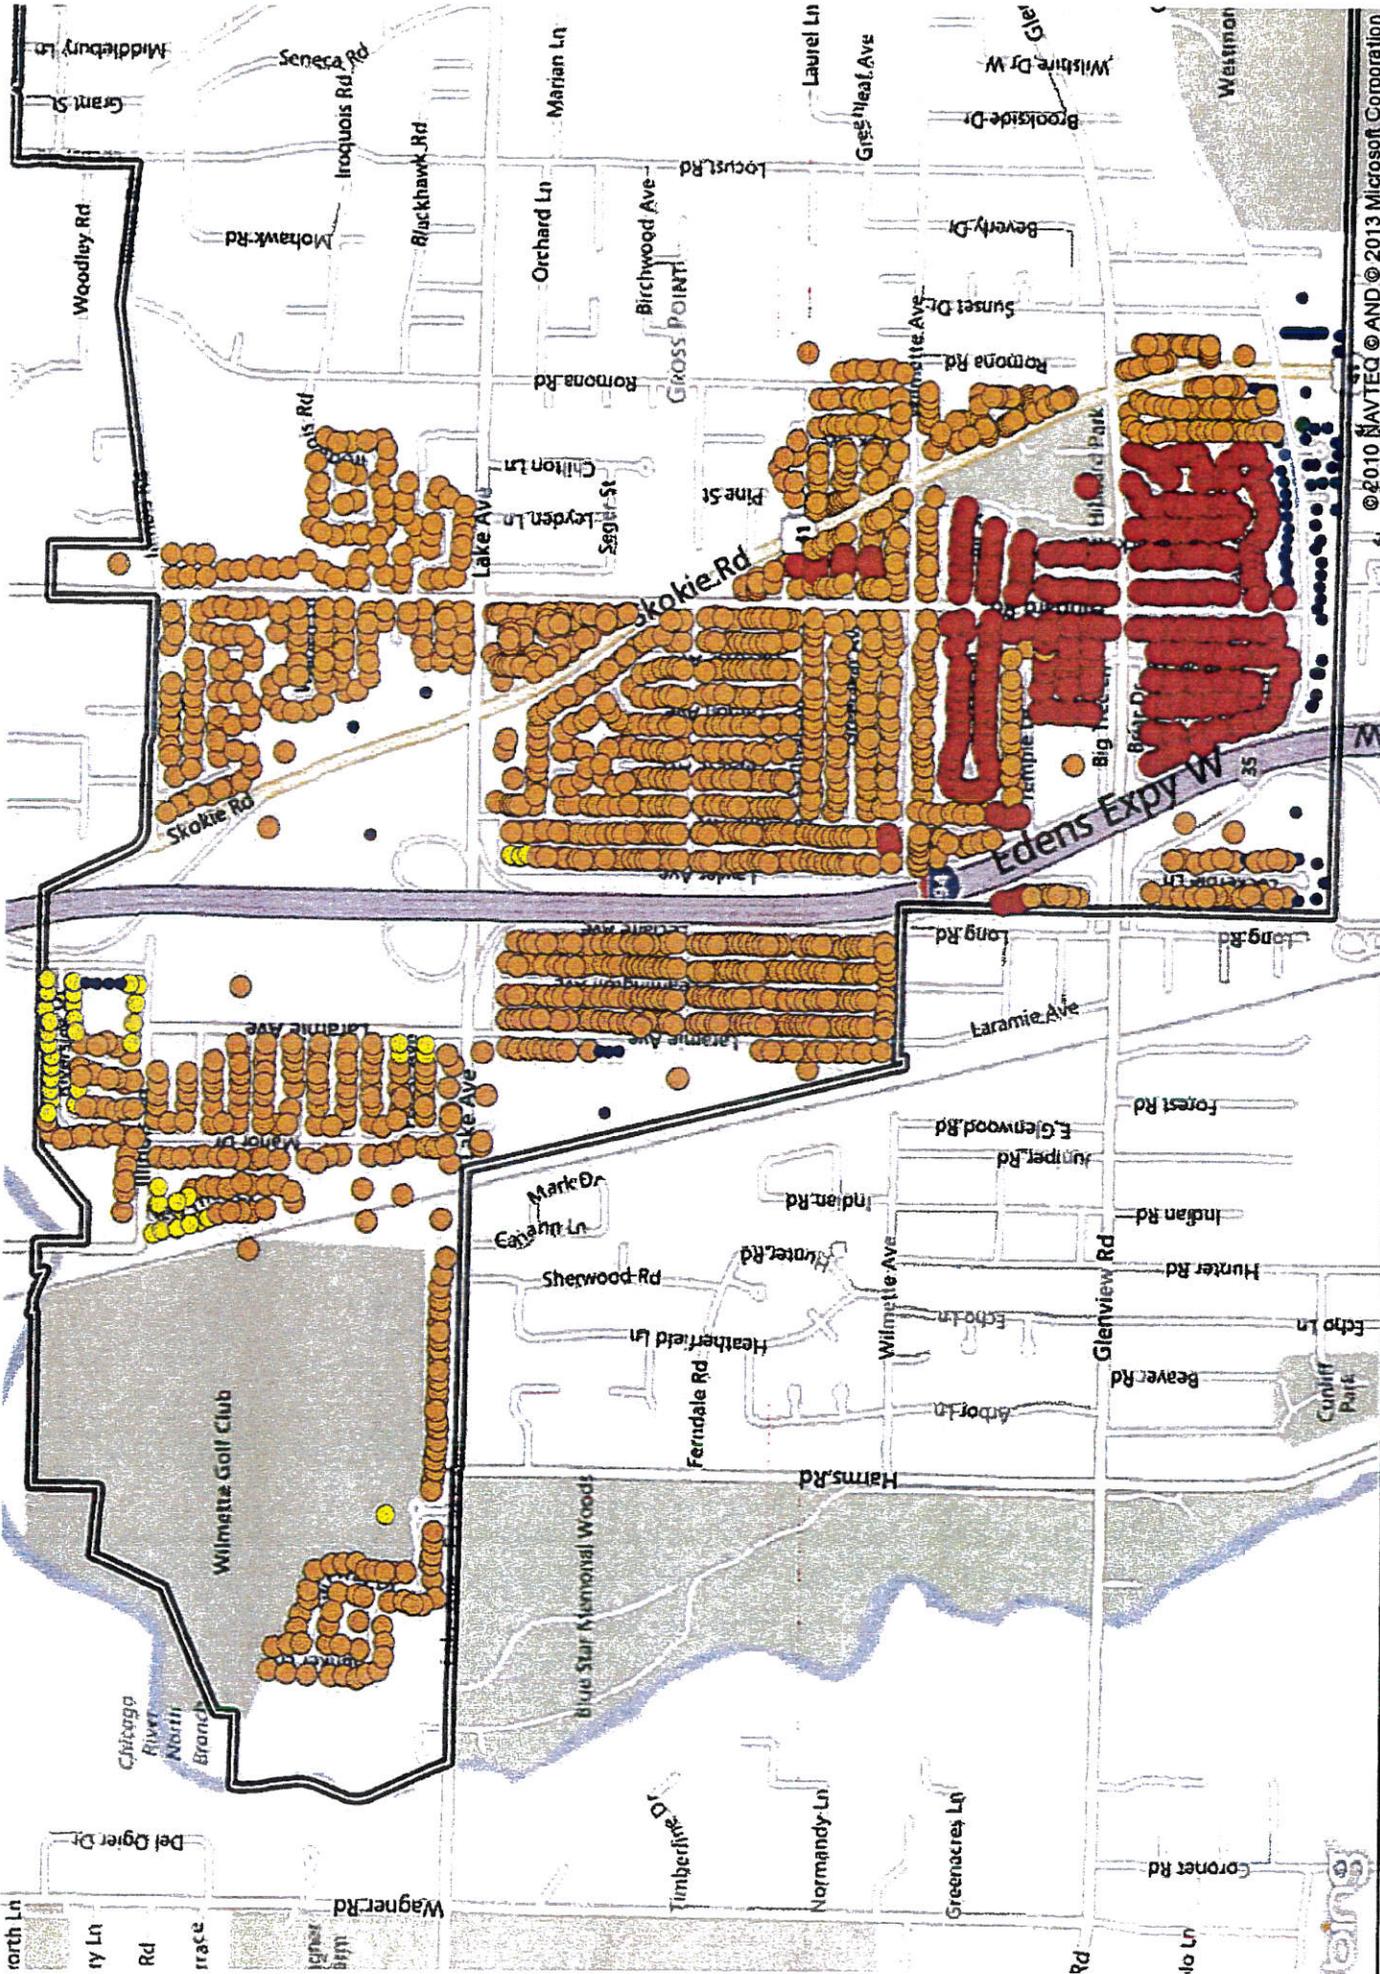
Village of Wilmette
 Exhibit 1
 Harms Rd Region - Existing Level of Protection
 June 2013

● Less than 1-year Protection
 ● 1-year to 5-year Protection
 ● 5-year to 25-year Protection
 ● 25-year to 100-year Protection
 Wilmette Boundary

● Greater than 100-year Protection

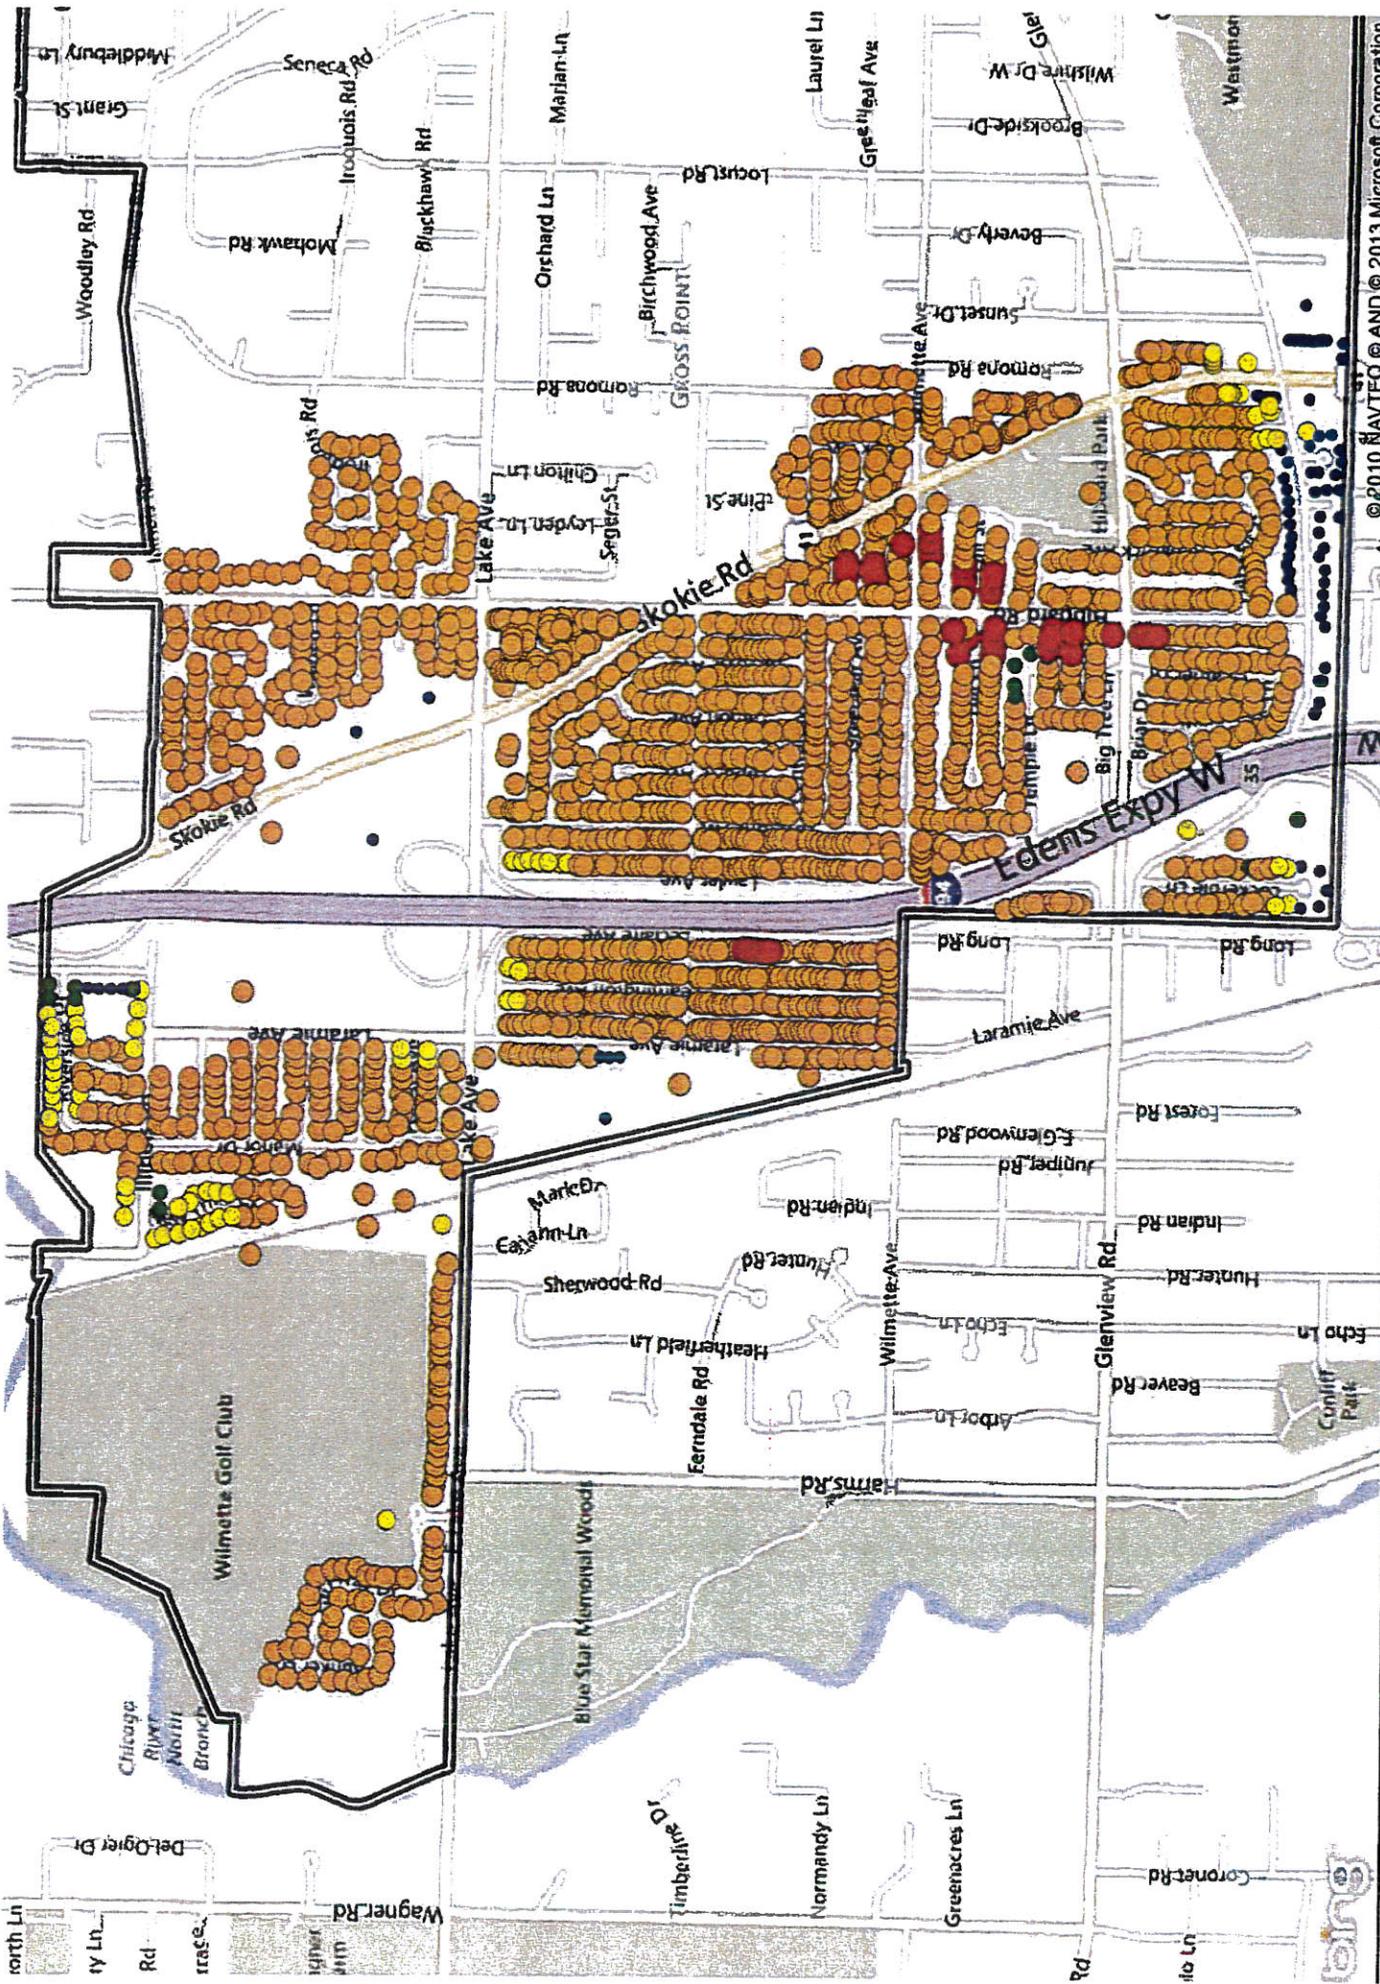
© 2010 NAVTEQ © AND © 2013 Microsoft Corporation
 Village of Wilmette
 Exhibit 2
 Harms Rd Region - 1.5 MG Storage, Gravity Drained
 June 2013

● Less than 1-year Protection
● 1-year to 5-year Protection
● 5-year to 25-year Protection
● 25-year to 100-year Protection
 Greater than 100-year Protection
 Wilmette Boundary

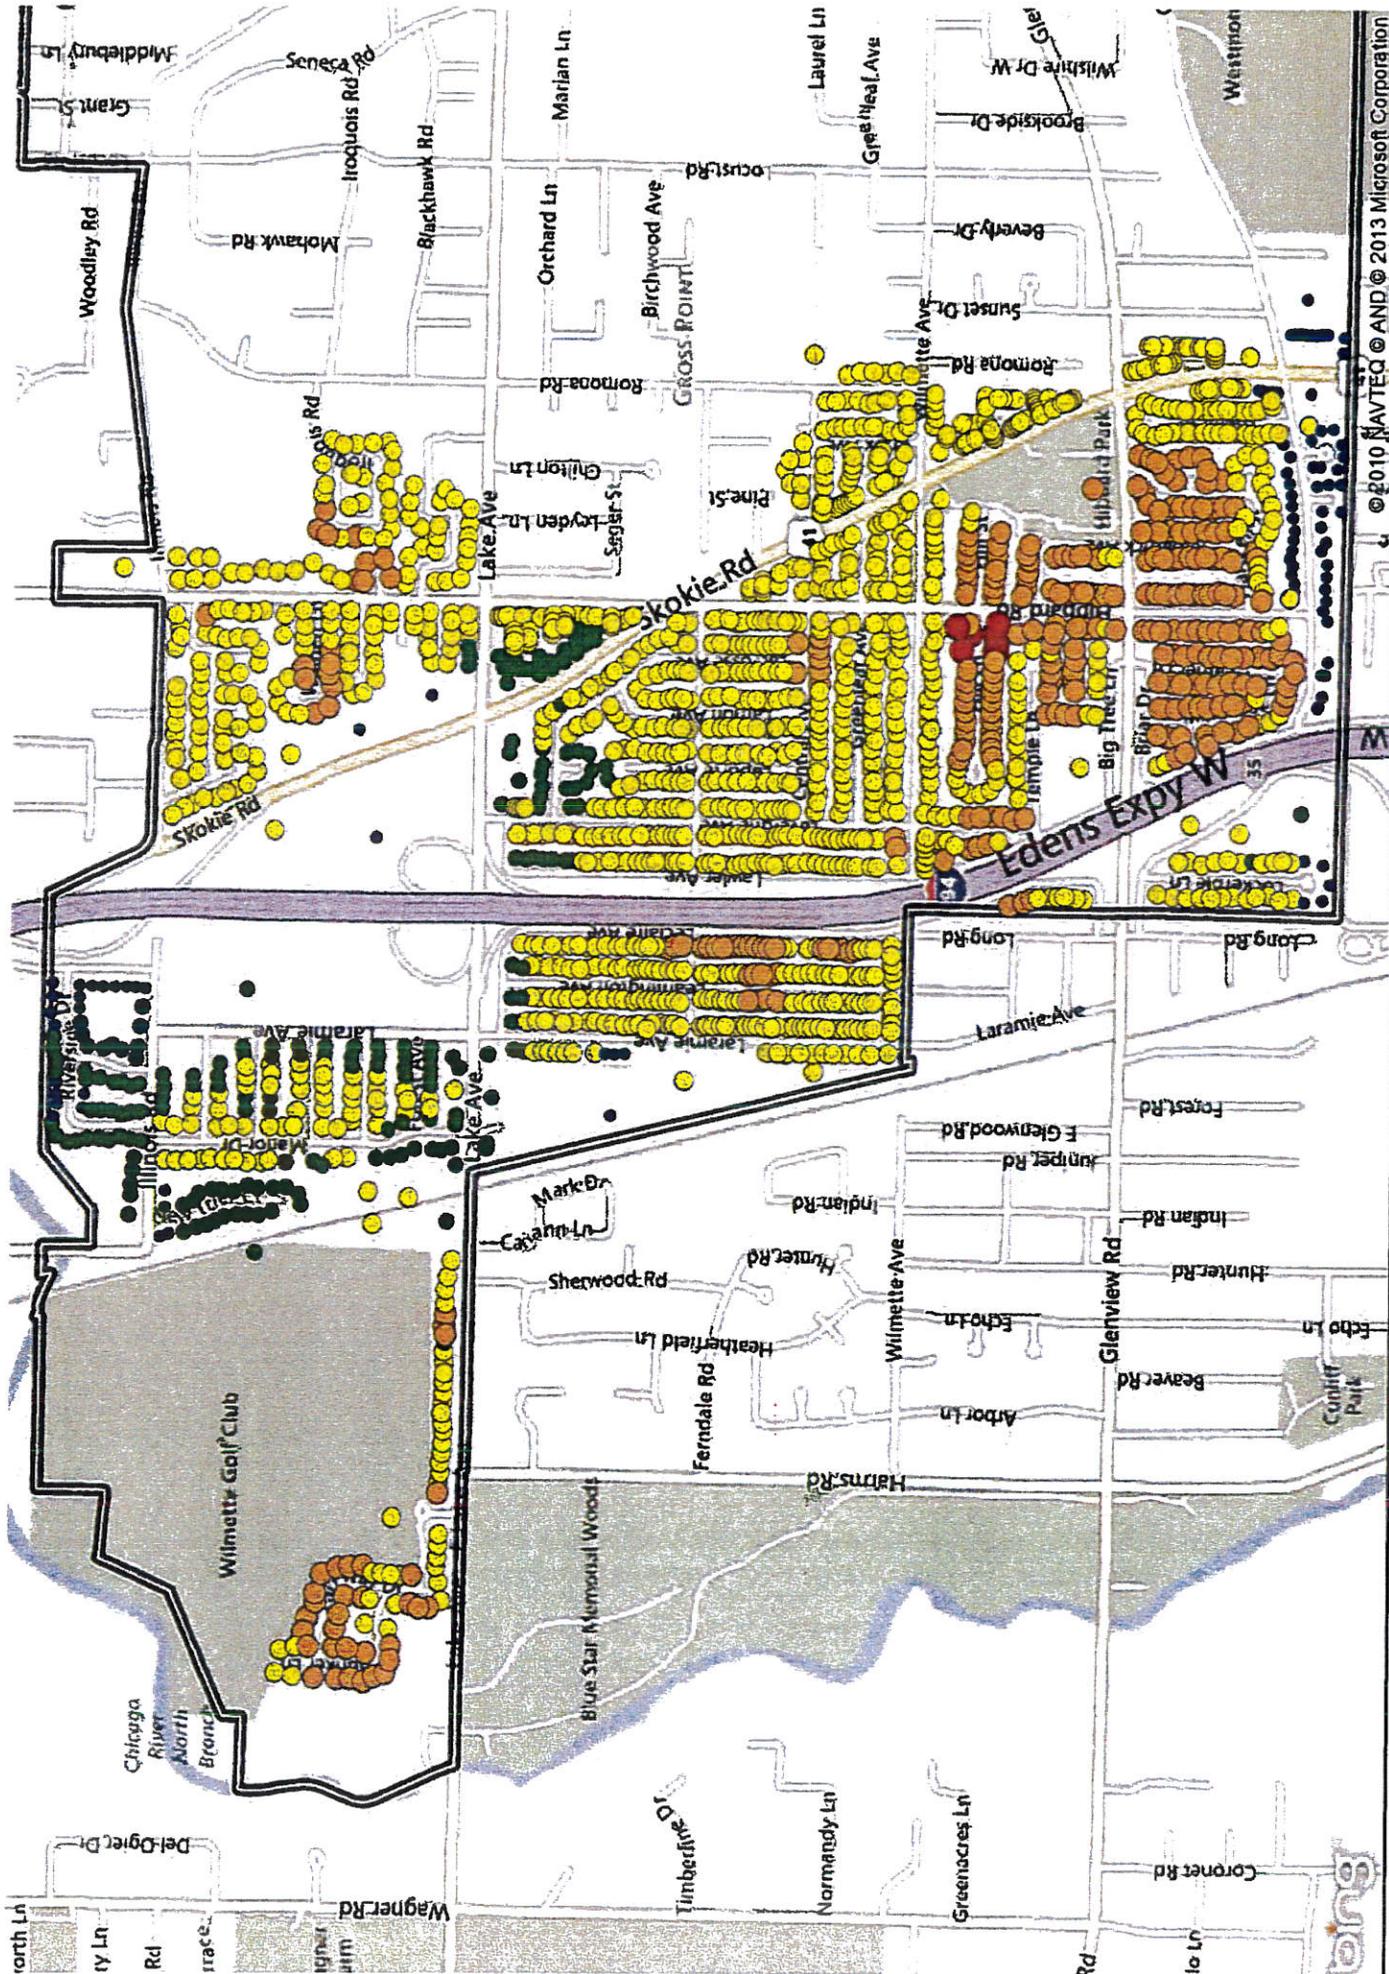
© 2010 NAVTEQ © AND © 2013 Microsoft Corporation
 Village of Wilmette
 Exhibit 6
 Harms Rd Region - 8.0 MG Storage, Gravity Drained
 June 2013

- Red circle: Less than 1-year Protection
- Orange circle: 1-year to 5-year Protection
- Yellow circle: 5-year to 25-year Protection
- Black circle: Greater than 100-year Protection

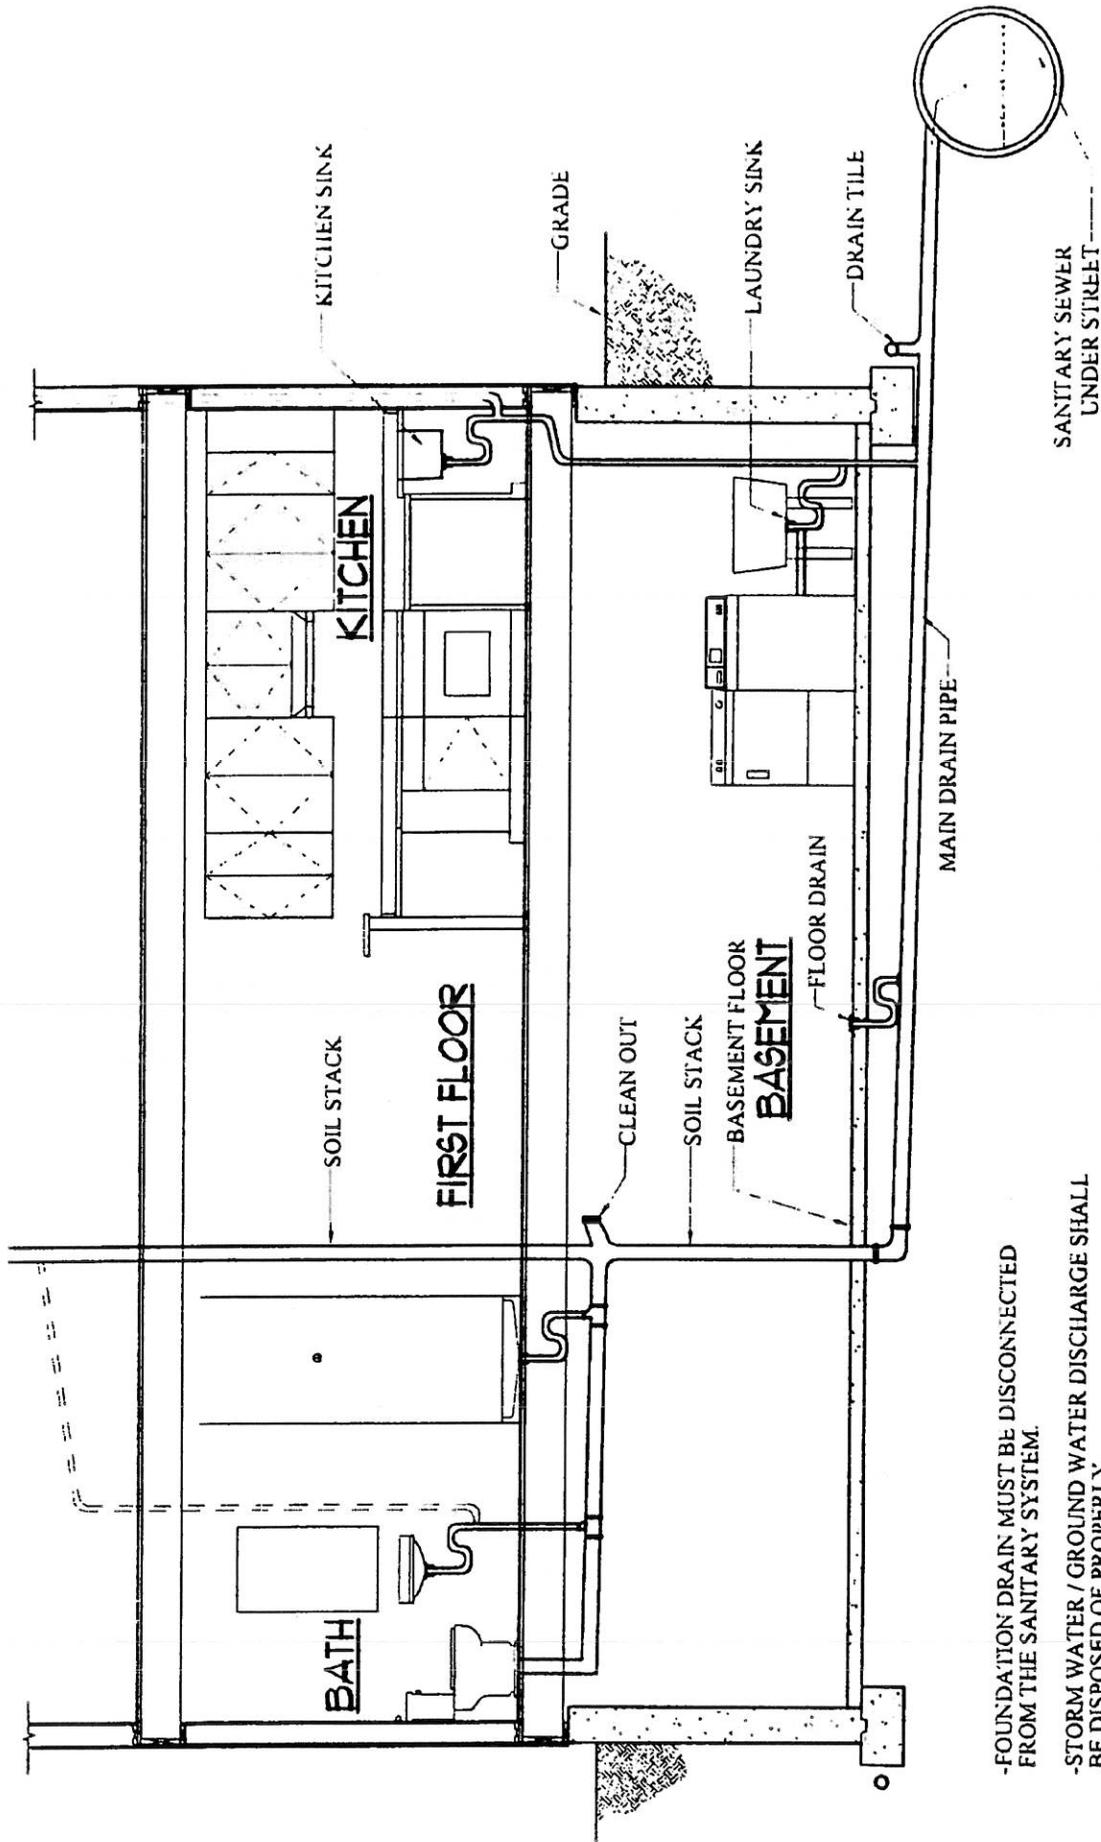
SKETCH A : EXAMPLE OF A TYPICAL GRAVITY DRAINAGE SYSTEM

-FOUNDATION DRAIN MUST BE DISCONNECTED FROM THE SANITARY SYSTEM.

-STORM WATER / GROUND WATER DISCHARGE SHALL BE DISPOSED OF PROPERLY.

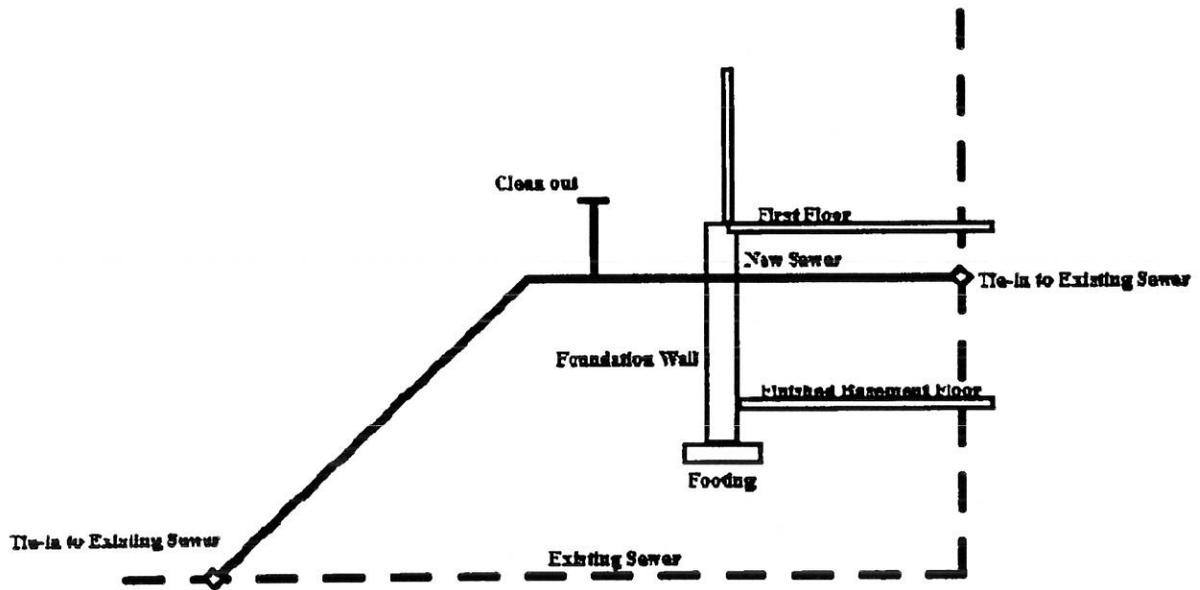
Sewer Rebate Drawing # 1

The overhead system is illustrated below in drawings 1 and 2:

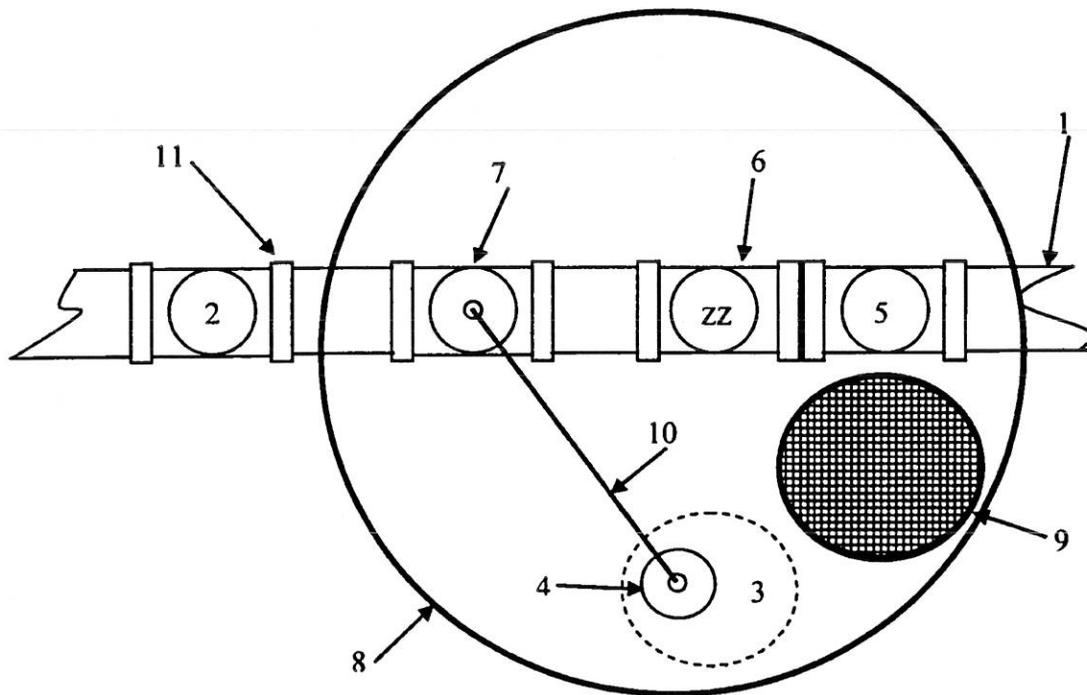
SEWER REBATE DRAWING #3

This alternate flood control system is designed to prevent sewage from backing up from the Village sanitary sewer and entering into the house or building. The design is based on the installation of a manhole and valve system that will be located on the private sewer line between the Village sewer and the building. Please refer to the Drawings #3 and #4 as shown.

During sewage backup, the sewer system from the house can still operate through the 2-inch ejector pumping system. The residential sanitary sewer wastewater will discharge out of the overflow pipe and into the sump pit. Once the sewage reaches a certain level in the pit, the ejector pump will be activated to discharge the sewage through the 2-inch plastic pipe to the street side of the sewer line. The check valve #3 has to be installed on this 2-inch line to prevent any sewage backflow through the pump. The flood control system is illustrated in drawings #3 and #4:

- 1 = SDR 26 Pipe
- 2 = SDR 26 6x6 Tee for clean out
- 3 = Min. 24" PVC / Fiberglass Pump Pit
- 4 = Ejector Pump - Check & Ball Valve Combo
- 5 = Overflow Tee
- 6 = Double Check Valve

- 7 = 6" x 2" Tee for Ejector Sump Discharge
- 8 = 5' Concrete Pit
- 9 = Cast Iron Frame & Lid
- 10 = 2" PVC Pipe
- 11 = Non-Shear Coupling

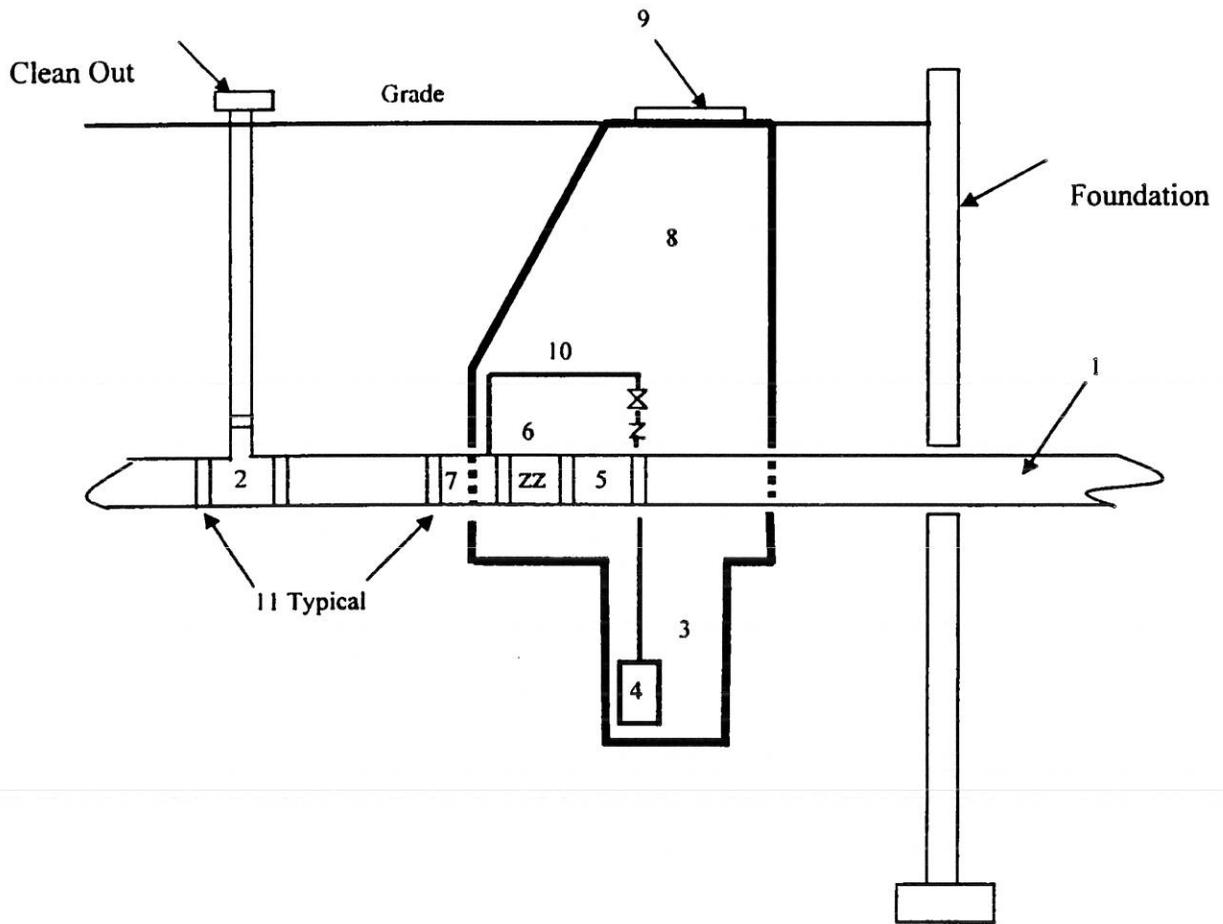
**SEWER REBATE
DRAWING # 4**

- 1 = SDR 26 Pipe
- 2 = SDR 26 6x6 Tee for clean out
- 3 = Min. 24" PVC / Fiberglass Pump Pit
- 4 = Ejector Pump – Check & Ball Valve Combo
- 5 = Overflow Tee
- 6 = Double Check Valve

- 7 = 6" x 2" Tee for Ejector Sump Discharge
- 8 = 5' Concrete Pit
- 9 = Cast Iron Frame & Lid
- 10 = 2" PVC Pipe
- 11 = Non-Shear Coupling
