Beechwood Ave. at 21st St.

Existing Conditions

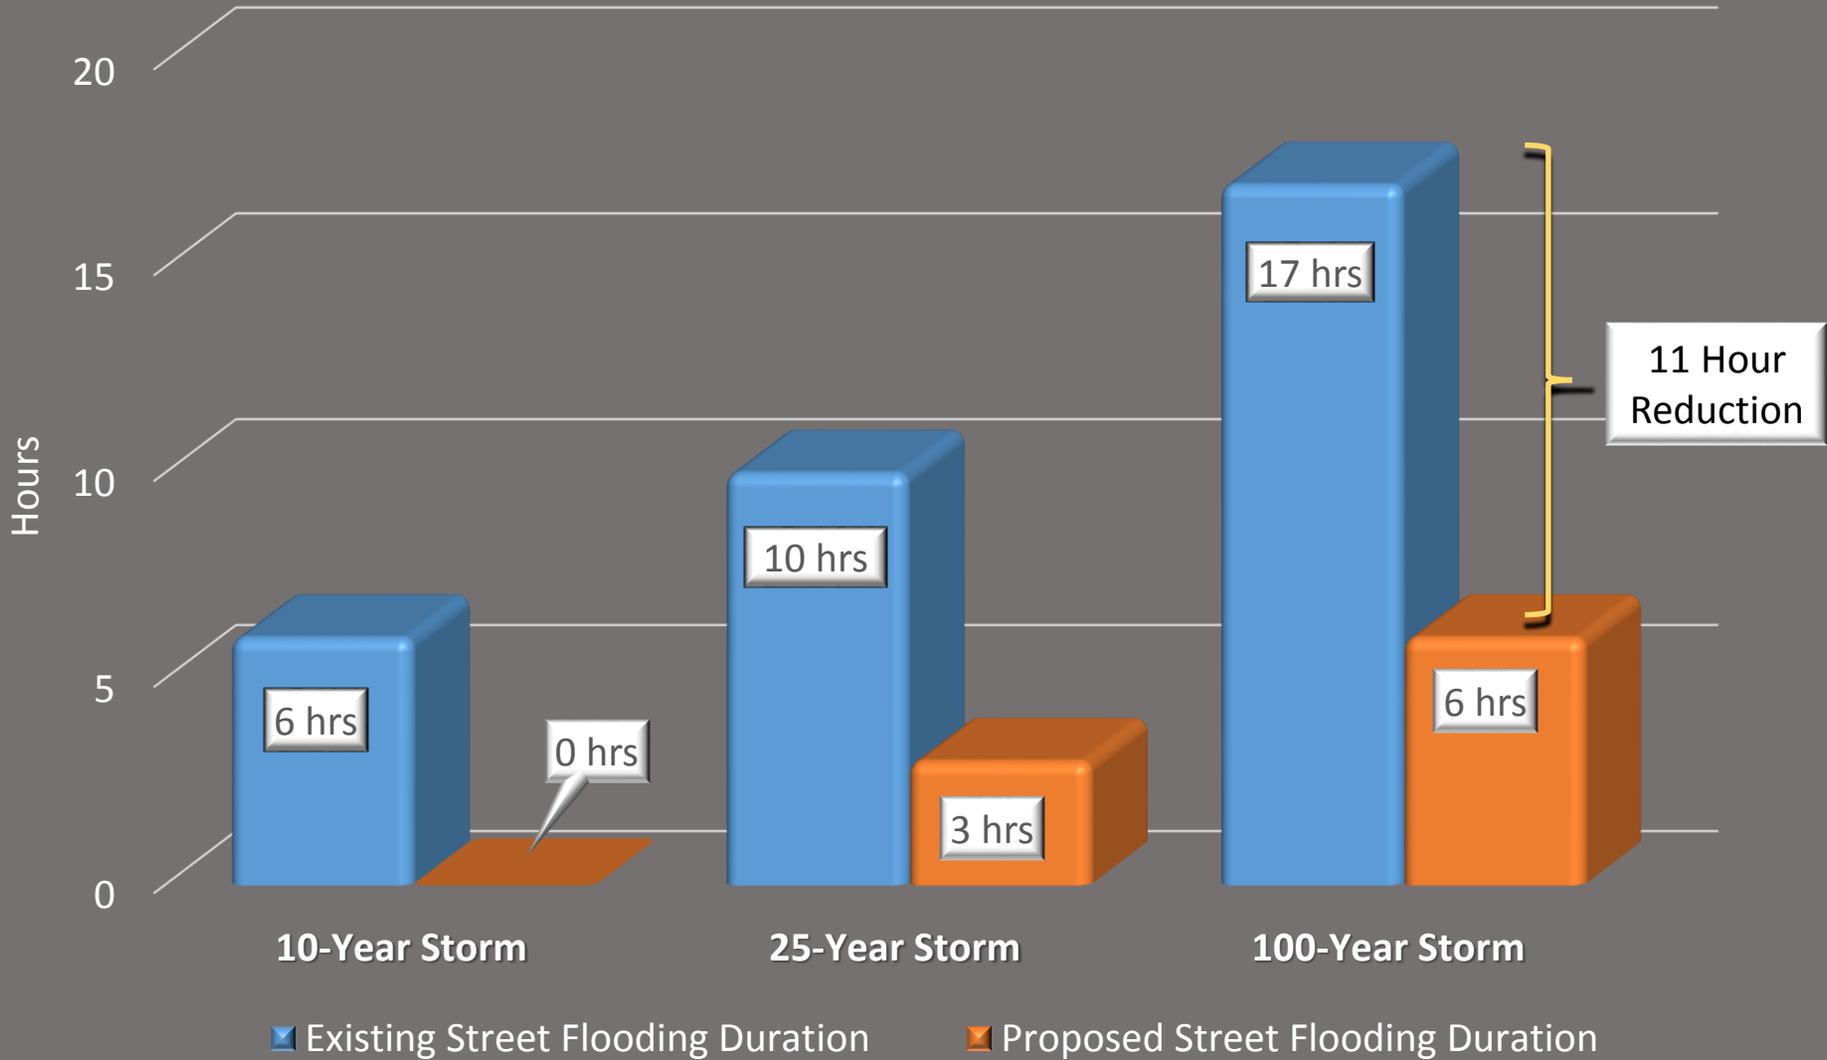
Beechwood Ave. at 21st St.

Existing Conditions vs Alternative 1
Reduction in Street Flooding Duration (Hours)

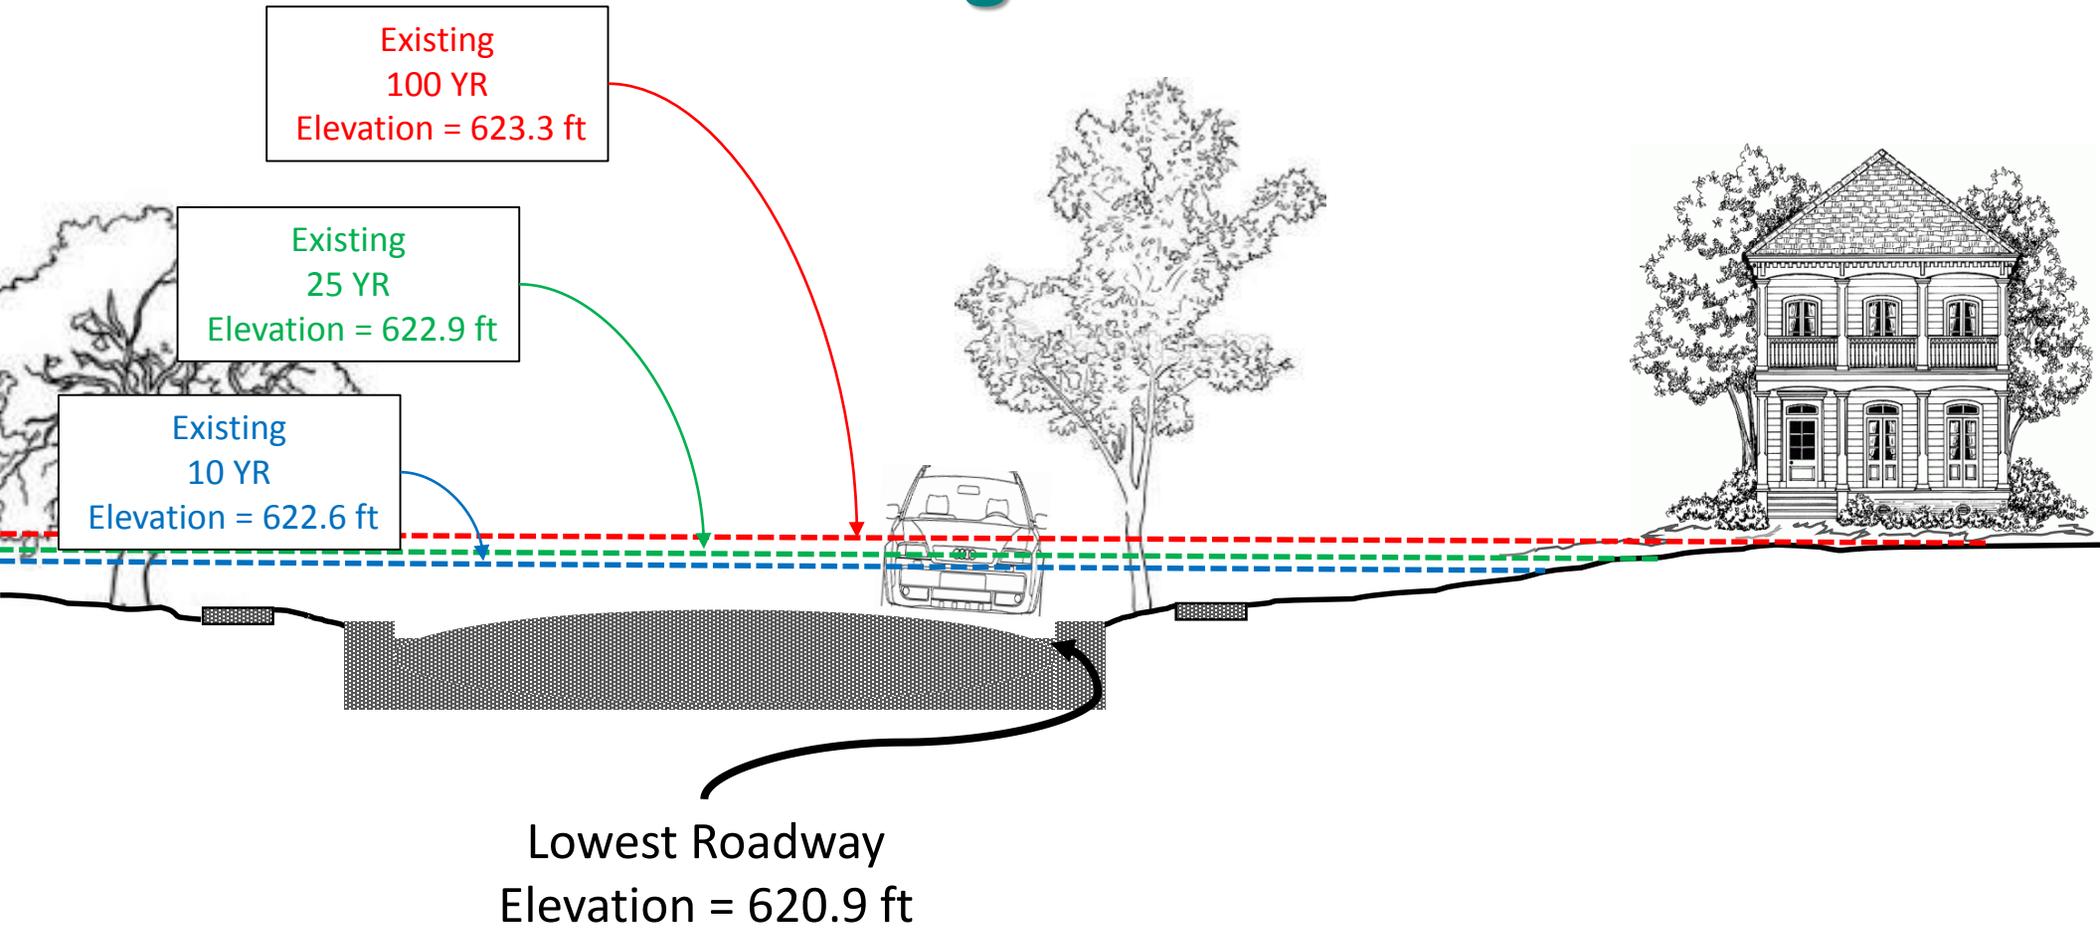
Wilshire Drive West Existing Conditions

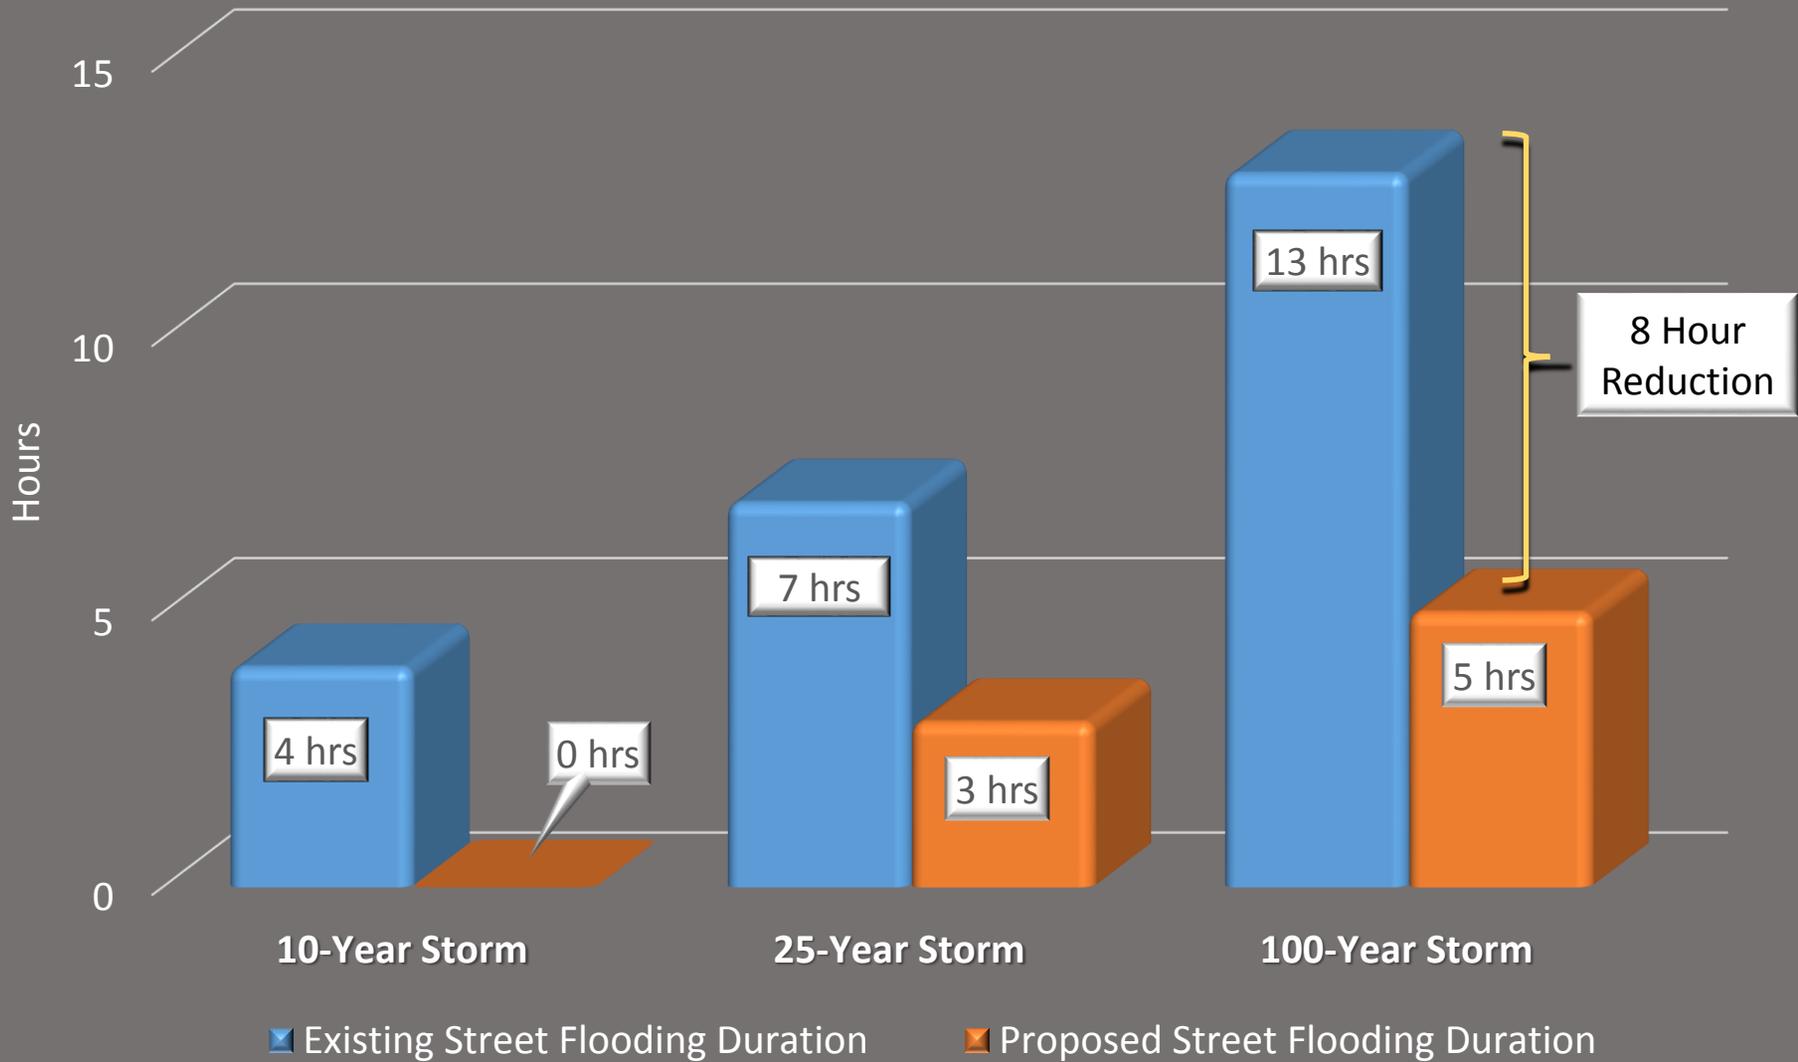
Wilshire Drive West

Existing Conditions vs Alternative 1
Reduction in Street Flooding Duration (Hours)

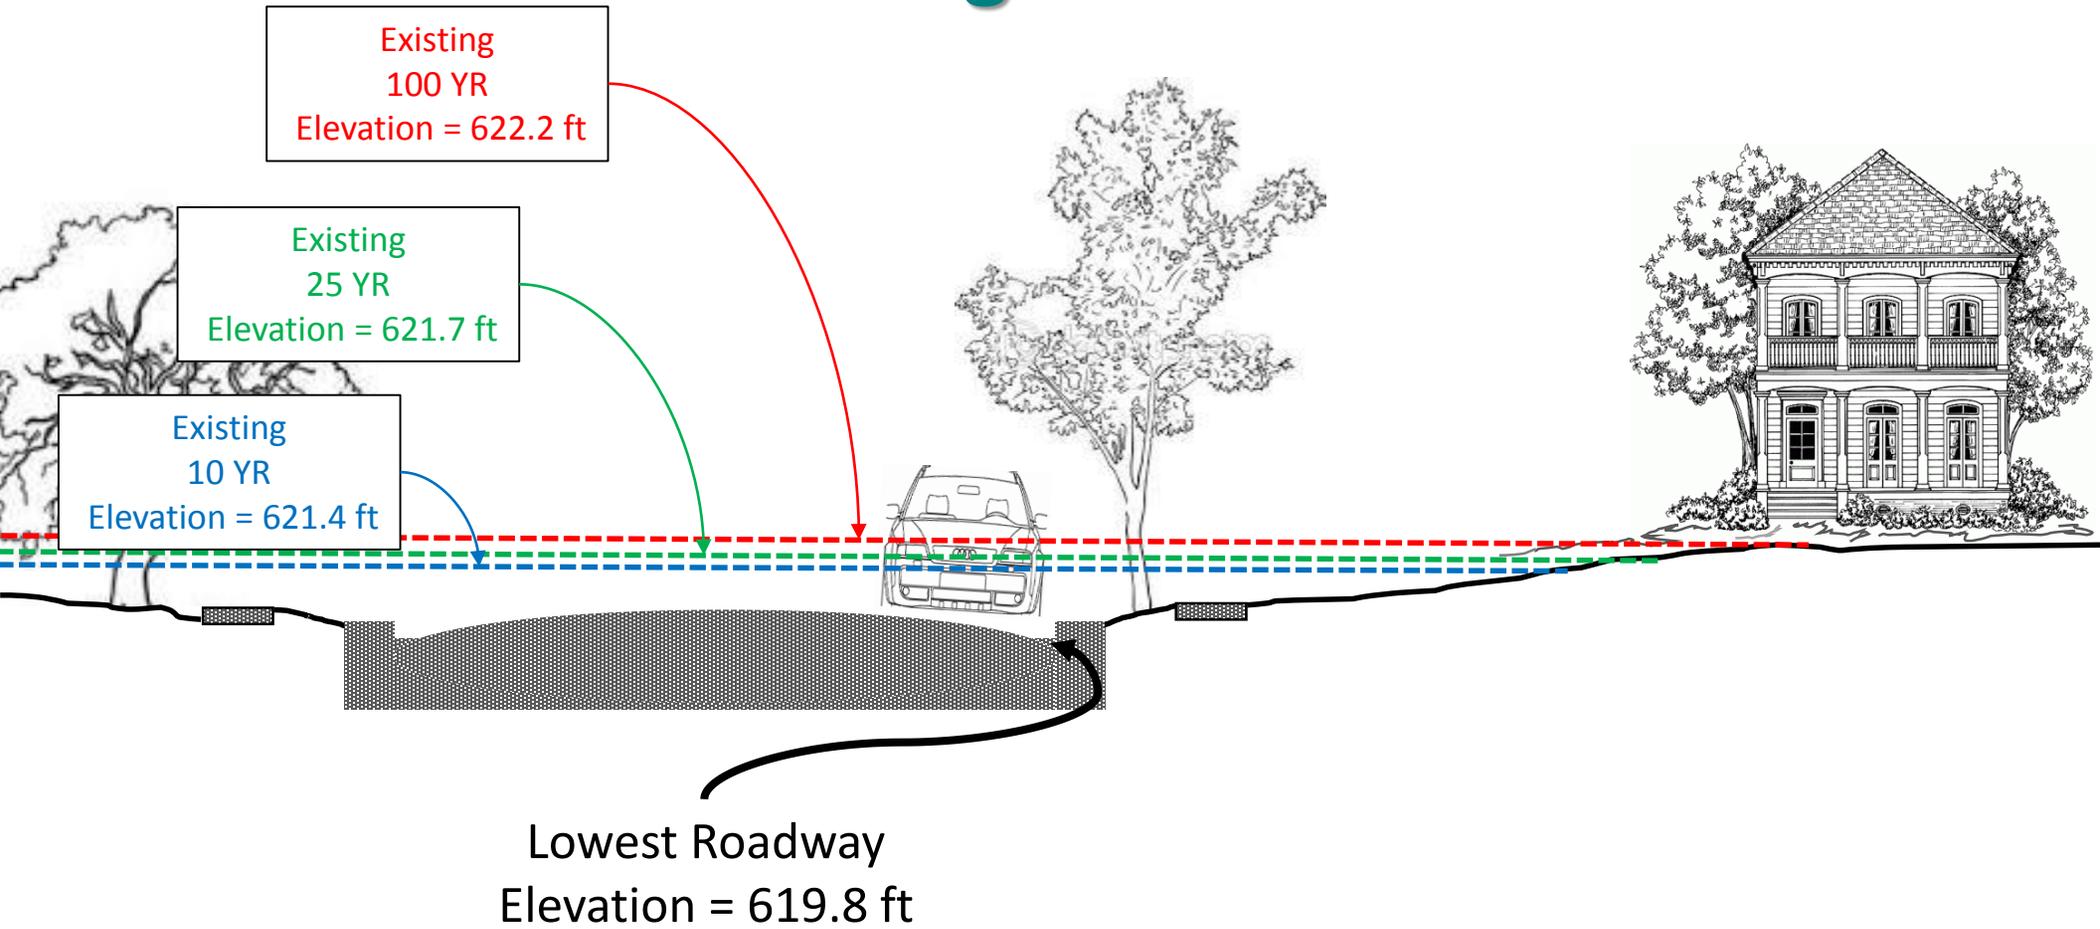
Kilpatrick Avenue Existing Conditions

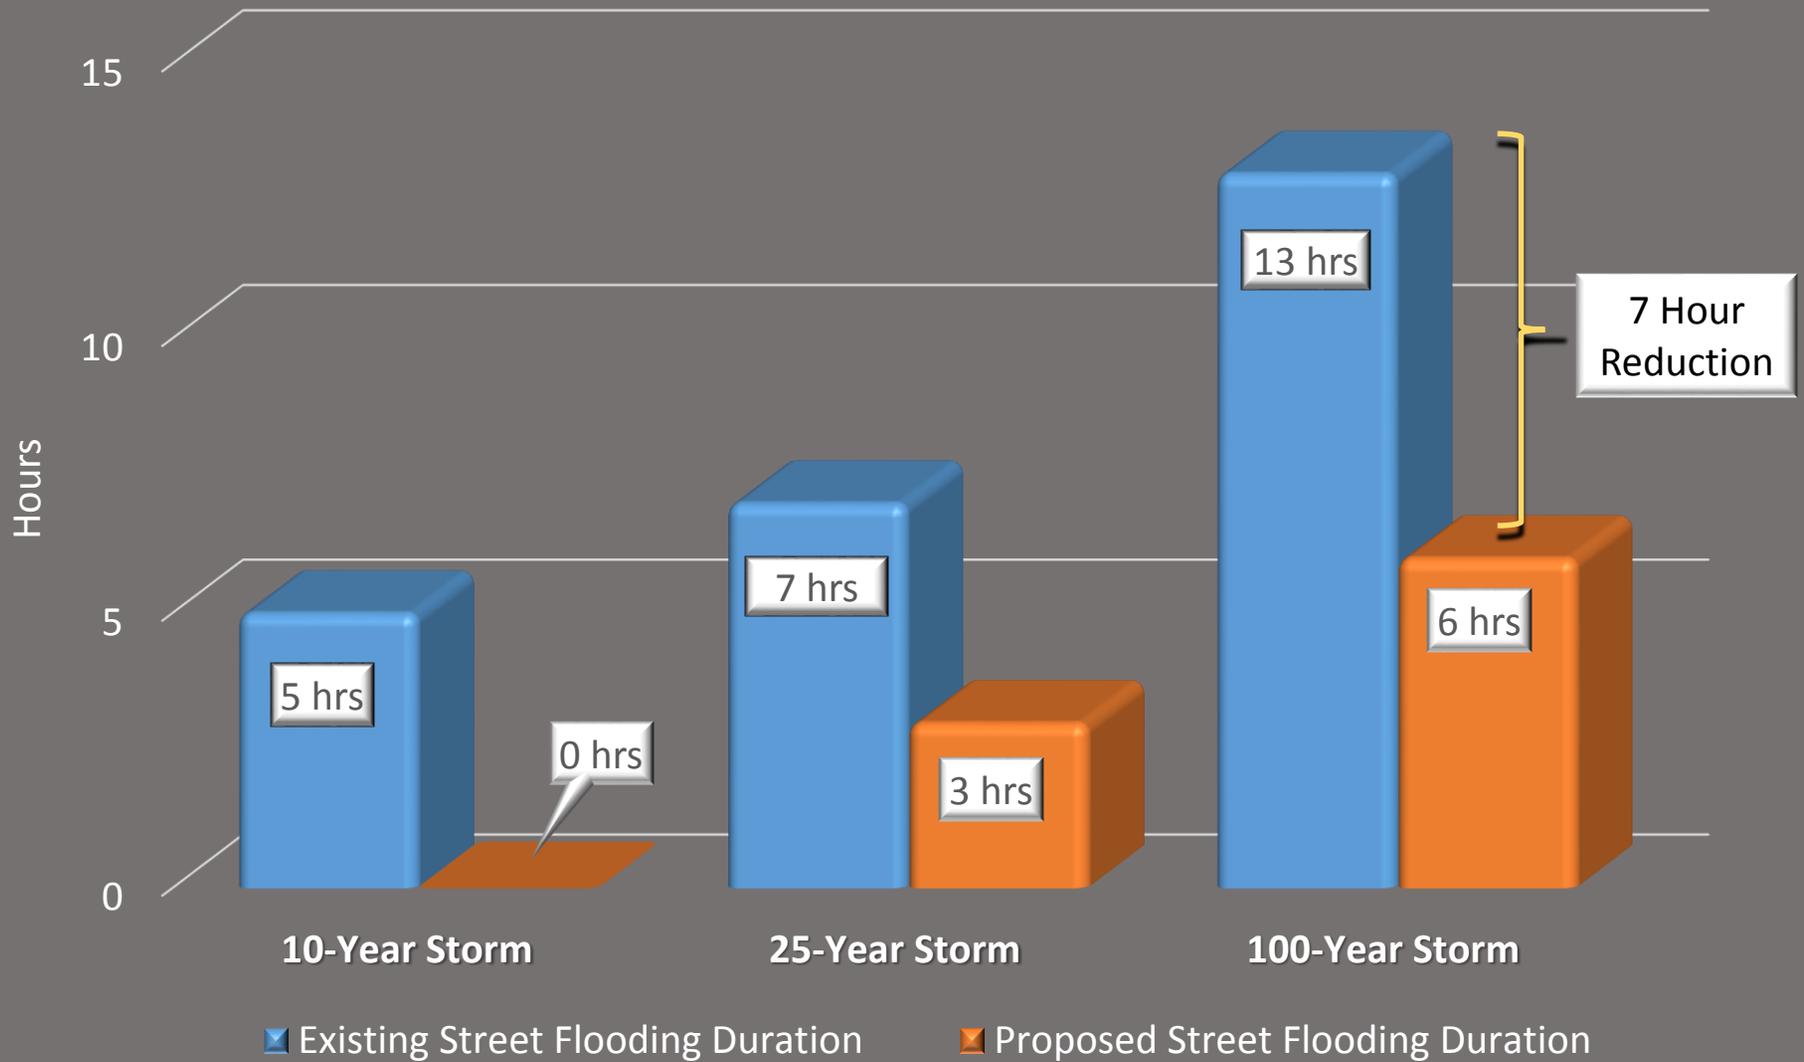
Kilpatrick Avenue

Existing Conditions vs Alternative 1
Reduction in Street Flooding Duration (Hours)
